Idanha-Detroit RFPD

Mari_fir40A

FEMA 154 Rapid Visual Screening Score Card

Rapid Visual Screening - Senate Bill #2 - Seismic Needs Assessment
Oregon Department of Geology and Mineral Industries

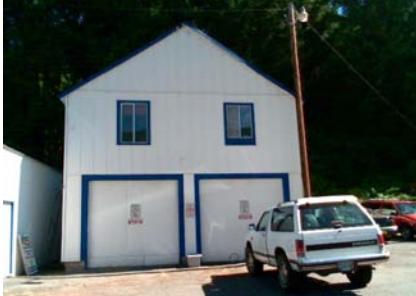
S	General Site	S	Falling Hazard

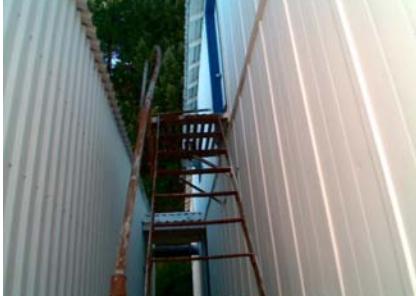
Enrollment	Year Built (Field Verified)	Year Built (Alt. Source)	Est. Decade Built
		1957	1940
Total Area (square ft)	Number of Stories	Basement	Pounding Potential
	2	No	Yes
Plan Irregularities		Vertical Irregularities	
Reentrant Corners: Other		None	
Torsion: Eccentric Stiffness		None	
None		None	
Falling Hazards		Poor Conditions	
Other: General		None	
None		None	
None		None

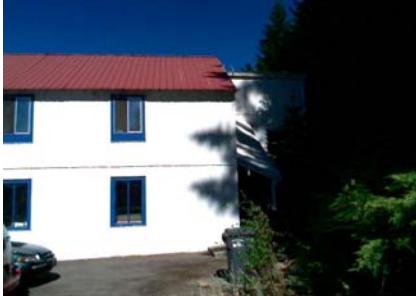
E	Plan Irregularity Primary	SW	Primary Structural Type

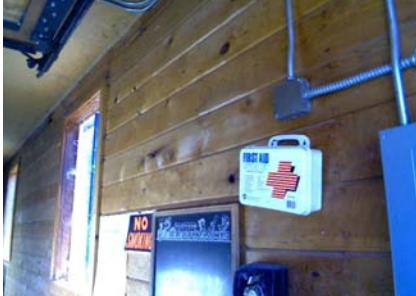
Final Type	Final Score
W1	4.1

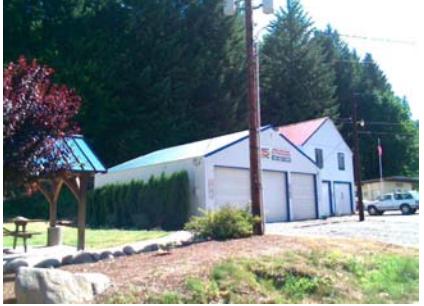
SW General Site		NW Plan Irregularity Primary

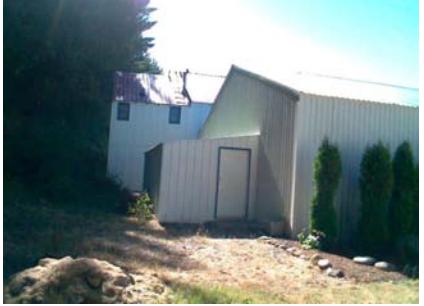
Enrollment	Year Built (Field Verified)	Year Built (Alt. Source)	Est. Decade Built
		1957	1970
Total Area (square ft)	Number of Stories	Basement	Pounding Potential
	1	No	Yes
Plan Irregularities		Vertical Irregularities	
Reentrant Corners:T shaped (Adjacent Build/Entity)		Steps in Elevation View: Single Change	
None		None	
None		None	
Falling Hazards		Poor Conditions	
None		None	
None		None	
None		None
