Monitor RFPD #58

Building Type Fire - RFPD	County Marion	
Street 15240 Woodburn Monitor Rd		
City Woodburn	State OR	Zip 97071
Latitude 45.10118	Longitude 122.74883	
Tracking Code New Building	Inspection Date 7/27/2006

FEMA 154 Rapid Visual Screening Score Card

Rapid Visual Screening - Senate Bill #2 - Seismic Needs Assessment
Oregon Department of Geology and Mineral Industries

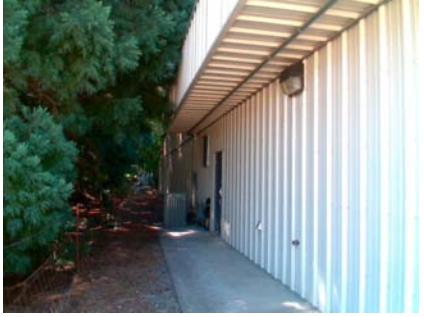
N Primary Structural Type S3		NW Plan Irregularity Primary
