Mt Angel Fire Dept

Mari_fir42A

Rapid Visual Screening - Senate Bill #2 - Seismic Needs Assessment
Oregon Department of Geology and Mineral Industries

Mari_fir42B

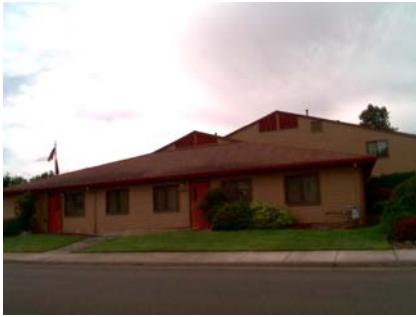
NE Elevation View		SE Elevation View

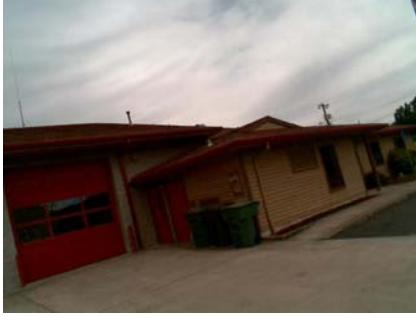
Enrollment	Year Built (Field Verified)	Year Built (Alt. Source)	Est. Decade Built
			1990
Total Area (square ft)	Number of Stories	Basement	Pounding Potential
	1	No	No
Plan Irregularities		Vertical Irregularities	
Reentrant Corners: Other		Steps in Elevation View: Single Change (Adjacent Building/Entity)	
Reentrant Corners: Other (Adjacent Build/Entity)		None	
None		None	
Falling Hazards		Poor Conditions	
None		None	
None		None	
None		None

SW Plan Irregularity Primary		SE Primary Structural Type

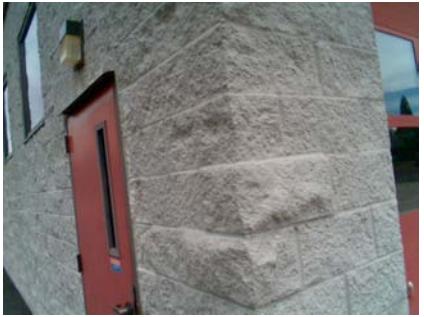
Type	Basic Score	Vert Irreg	Plan Irreg	Pre-Code	Post-Bench	Soil C	Soil D	Soil E	RVS Score
Primary	RM1	2.8	-1	-0.5	0	0	0	-0.6	0	0.7
Secondary		0	0	0	0	0	0	0	0	0
Tertiary		0	0	0	0	0	0	0	0	0

SW Primary Structural Type		NW Elevation View

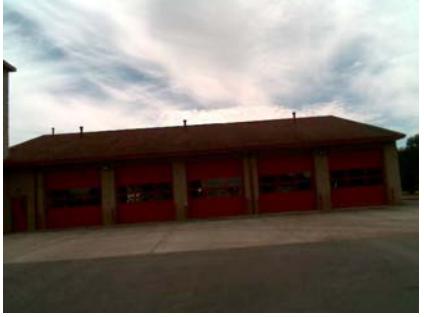
Enrollment	Year Built (Field Verified)	Year Built (Alt. Source)	Est. Decade Built
			1990
Total Area (square ft)	Number of Stories	Basement	Pounding Potential
	1	No	No
Plan Irregularities		Vertical Irregularities	
Reentrant Corners:Other (Adjacent Build/Entity)		Steps in Elevation View: 2 to 3 Changes (Adjacent Building/Entity)	
Lateral-Force-Resistance in One Direction Only		None	
None		None	
Falling Hazards		Poor Conditions	
None		None	
None		None	
None		None

NW Plan Irregularity Tertiary		N Elevation View
