Silverton Hospital

Mari_hos01A

FEMA 154 Rapid Visual Screening Score Card

Rapid Visual Screening - Senate Bill #2 - Seismic Needs Assessment
Oregon Department of Geology and Mineral Industries

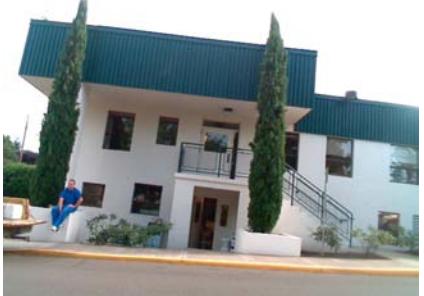
W Vertical Irregularity Tertiary		N Elevation View

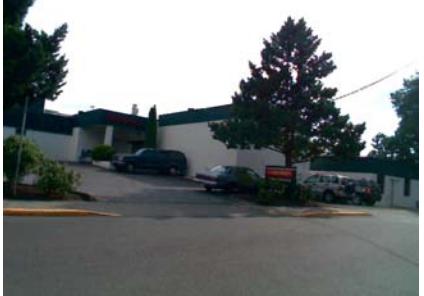
N Plan Irregularity Primary

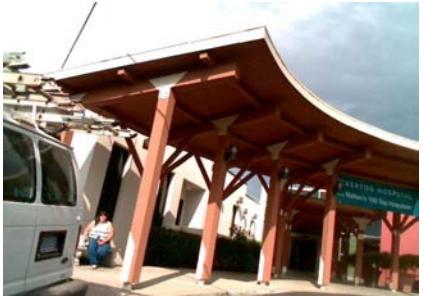
W Elevation View		W General Site MAIN ENTRY AND CONN TO NEW
