| Tracking Code RVS in 2006 | Inspection Date 8/1/2006 | |

FEMA 154 Rapid Visual Screening Score Card

Mt Angel Police Dept

Rapid Visual Screening - Senate Bill #2 - Seismic Needs Assessment
Oregon Department of Geology and Mineral Industries

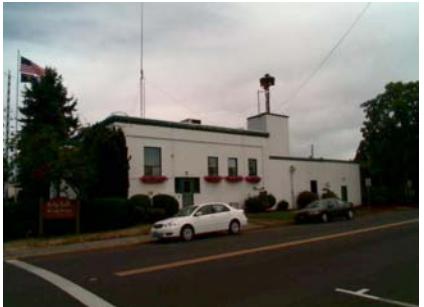
| SW General Site | | W Elevation View | |

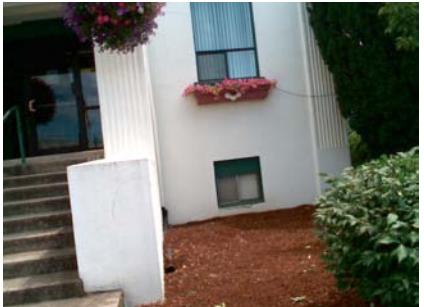
| | | W Basement | |

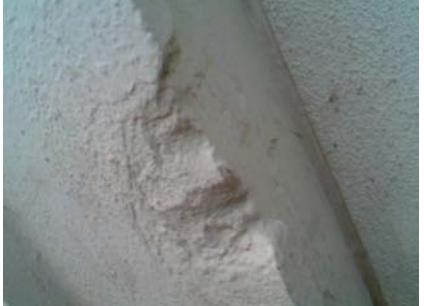
| | | NW Primary Structural Type C2 | |

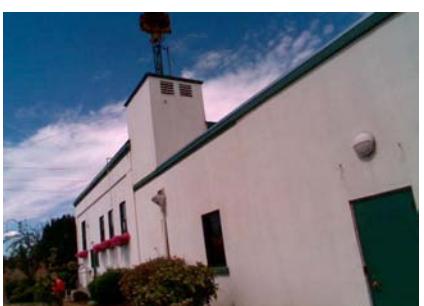
| None | | Steps in Elevation View: 2 to 3 Changes | |
| NE General Site | | E Vertical Irregularity Primary | |
