Stayton Police Dept

Mari_pol13A

FEMA 154 Rapid Visual Screening Score Card

Rapid Visual Screening - Senate Bill #2 - Seismic Needs Assessment
Oregon Department of Geology and Mineral Industries

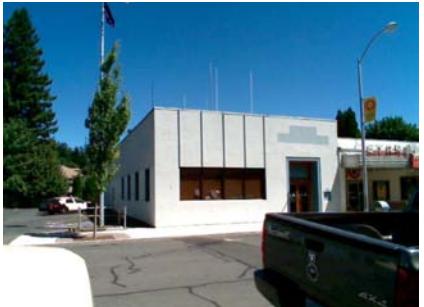
NW General Site		NE General Site

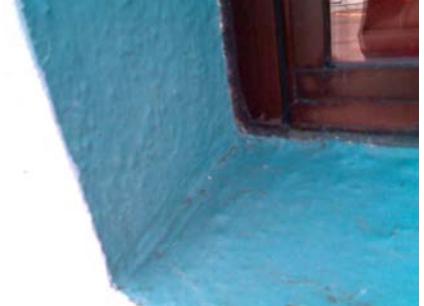
NW Primary Structural Type		NW Secondary Structural Type

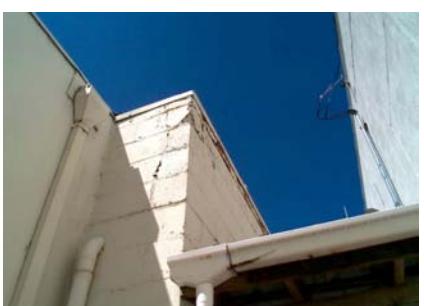
W Building Name		SE Poor Condition
