Hubbard Police Dept

City of Hubbard

Building Type Police - City	County Marion	
Street 3720 2nd St		
City Hubbard	State OR	Zip 97032
Latitude 45.18263	Longitude 122.80508	
Tracking Code RVS in 2006	Inspection Date 7/26/2006

FEMA 154 Rapid Visual Screening Score Card

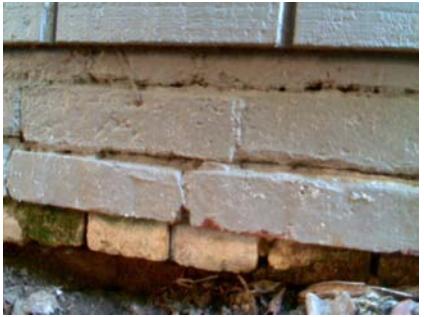
NE Building Quality brick foundation, police officer said it goes down about 6 inches.

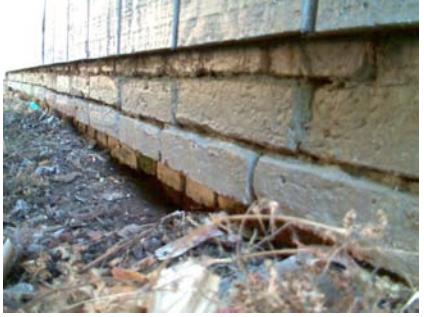
N Building Quality		NW Building Quality whole wall is sliding off foundation
