Salem City Hall

Mari_pol30A

Rapid Visual Screening - Senate Bill #2 - Seismic Needs Assessment
Oregon Department of Geology and Mineral Industries

Salem Civic Center Garage

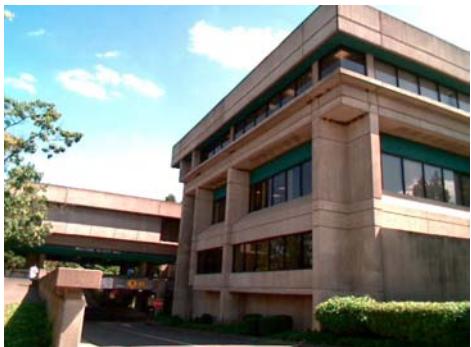
NW Vertical Irregularity Secondary

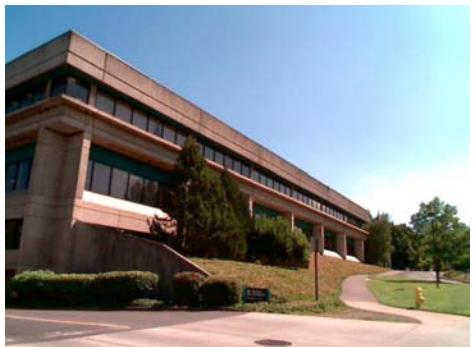
NW Vertical Irregularity Primary

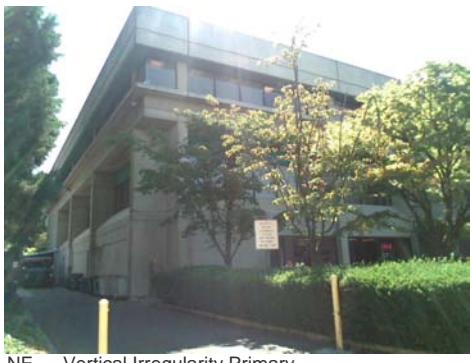
NE Vertical Irregularity Primary

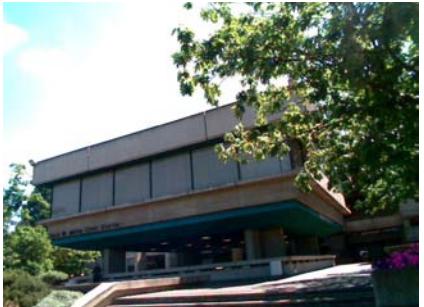
| S Primary Structural Type SEE POLICE CAR TO LEFT | N Falling Hazard | W Elevation View | |

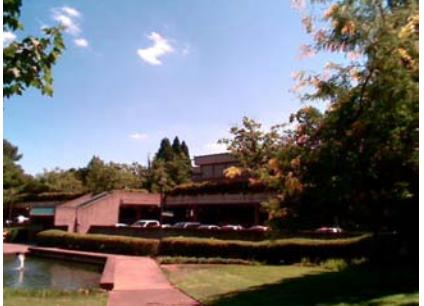
| NW Elevation View | NW Secondary Structural Type | NW Vertical Irregularity Primary | |

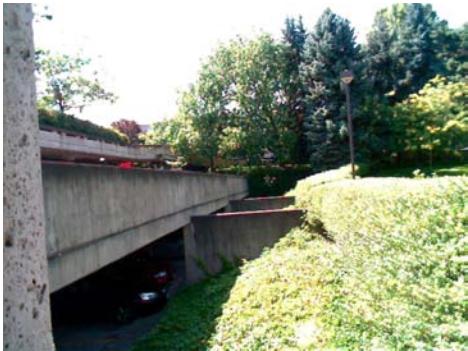
NE Vertical Irregularity Primary

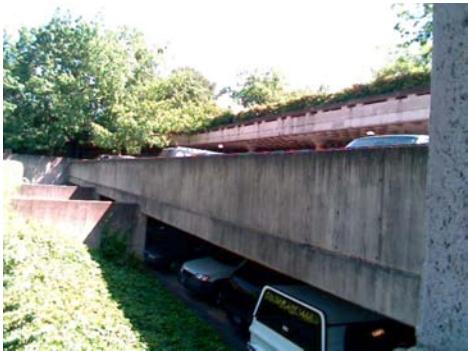
NW Vertical Irregularity Primary
