# North Marion High School

Mari\_sch10A

## FEMA 154 Rapid Visual Screening Score Card

Rapid Visual Screening - Senate Bill #2 - Seismic Needs Assessment  
Oregon Department of Geology and Mineral Industries

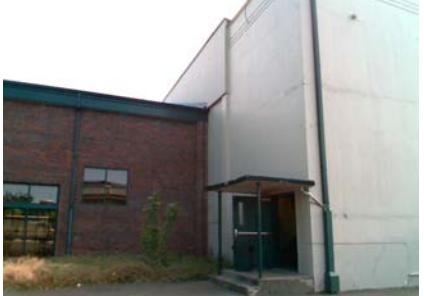
SW General Site new bldg (2000) on left. No visible seismic joint in inside or outside.	S Primary Structural Type	NE General Site new bldg wraps around front of bldg A

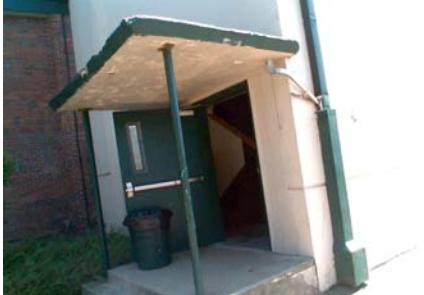
NE General Site	SW Falling Hazard	W Falling Hazard

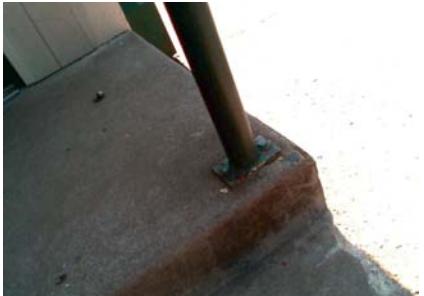
W Falling Hazard	W Falling Hazard	SE Falling Hazard

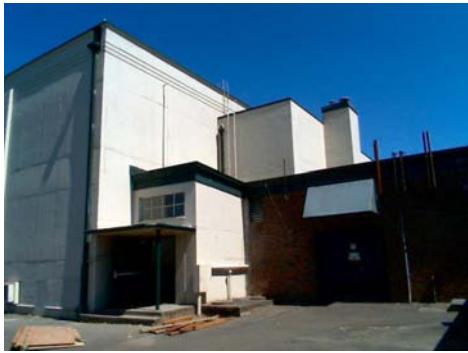
S Plan Irregularity Primary

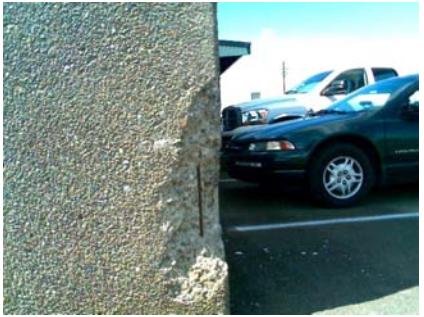
NE Poor Condition	SE Primary Structural Type	S General Site

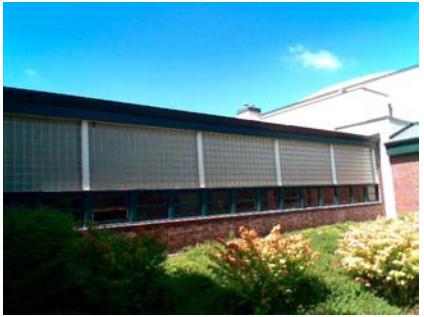
N General Site		NE Falling Hazard glass block

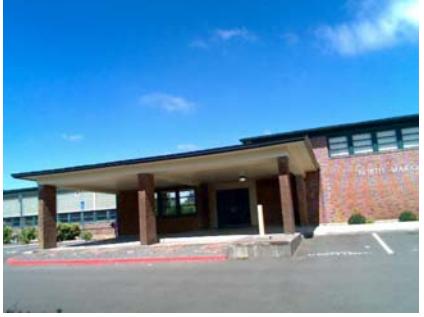
E Falling Hazard		SE Falling Hazard

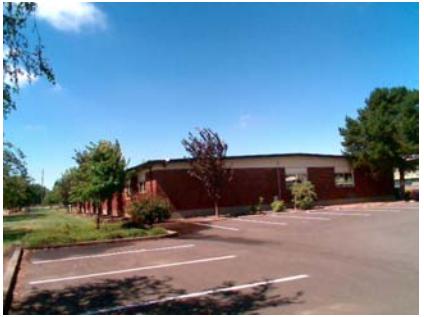
SE Falling Hazard

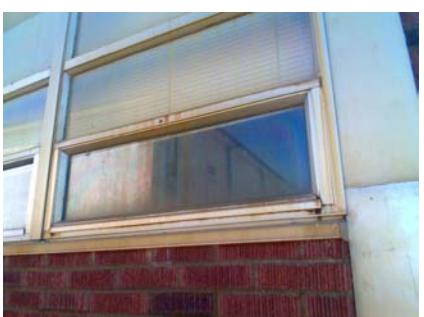
W Building Quality

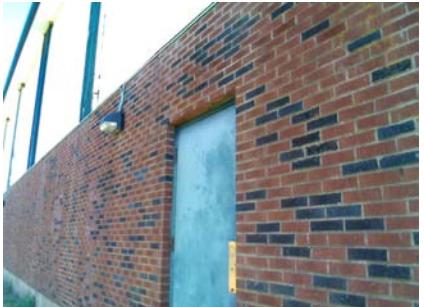
SW Falling Hazard	SW General Site	NE General Site plywood siding above brick.

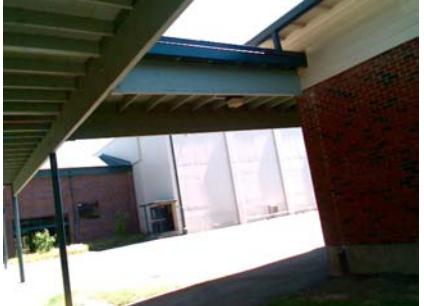
SW General Site	SW Pounding Potential	SW General Site

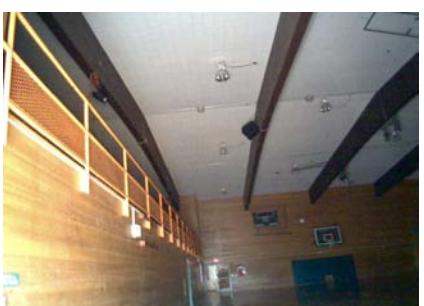
NE General Site	NE General Site	SW Primary Structural Type could not see columns but everything else is wood.
