Hoover Elementary School

Mari_sch22A

FEMA 154 Rapid Visual Screening Score Card

Rapid Visual Screening - Senate Bill #2 - Seismic Needs Assessment
Oregon Department of Geology and Mineral Industries

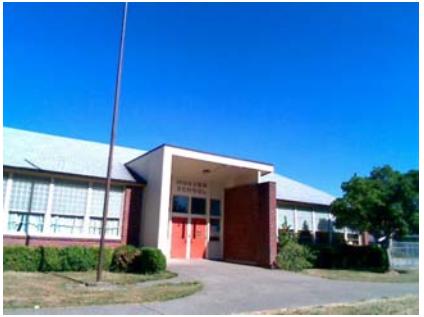
W Elevation View	W Elevation View	W Building Name

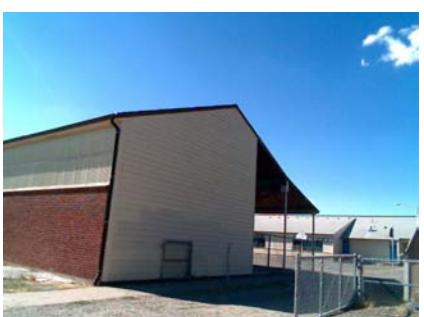
SE Primary Structural Type	E Falling Hazard	E Plan Irregularity Primary

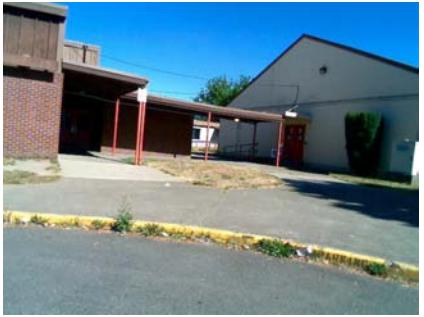
W Falling Hazard	S Elevation View	NE Elevation View
