Parrish Middle School

Mari_sch40A

FEMA 154 Rapid Visual Screening Score Card

Rapid Visual Screening - Senate Bill #2 - Seismic Needs Assessment
Oregon Department of Geology and Mineral Industries

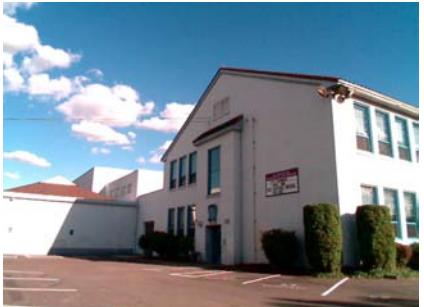
NW Falling Hazard WALL BETWEEN BLDGS	W Field Verified Year Built	S Elevation View

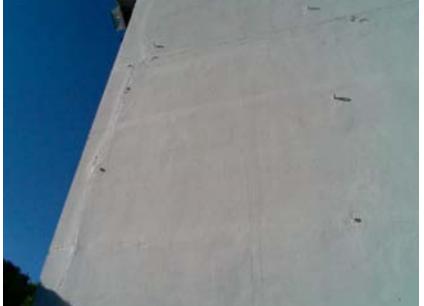
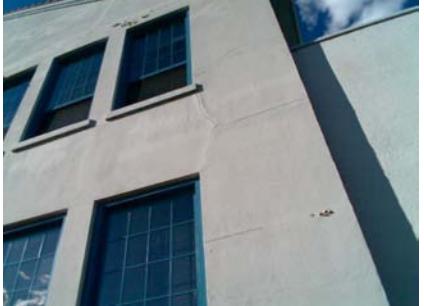
S Poor Condition	S Poor Condition	SE Vertical Irregularity Primary

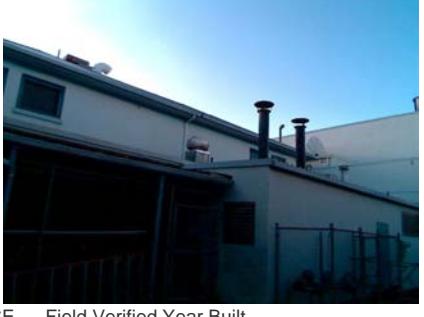
SE Field Verified Year Built CONN TO D, OLD WINDOWS

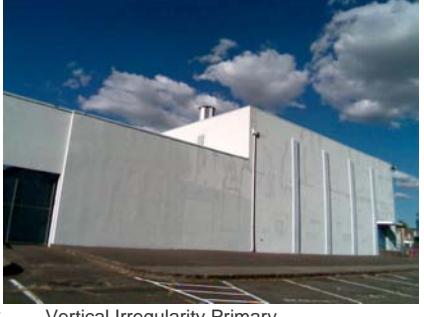
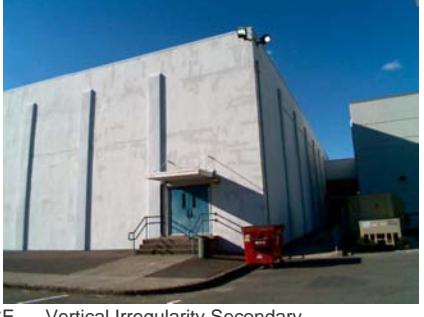
S Vertical Irregularity Primary		SE Vertical Irregularity Secondary

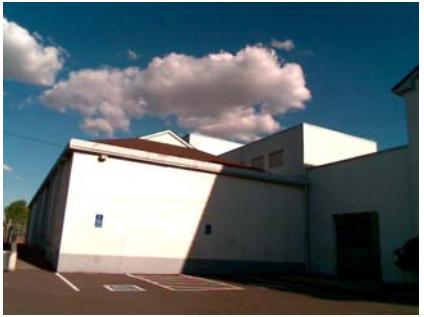
NW Field Verified Year Built GLASS BLOCK	NW Vertical Irregularity Primary	NW Elevation View

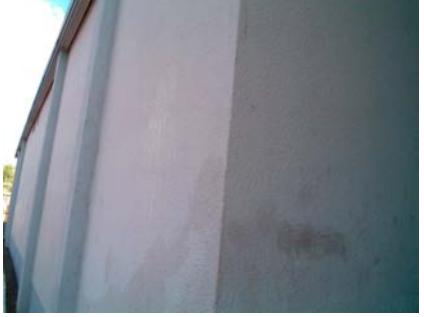
N Primary Structural Type NO CORNER JTS - SO PIP CONC	NE Vertical Irregularity Primary	SE Secondary Structural Type SMALL RM PART
