# North Salem High School

Salem-Keizer SD 24J

## FEMA 154 Rapid Visual Screening Score Card

Rapid Visual Screening - Senate Bill #2 - Seismic Needs Assessment  
Oregon Department of Geology and Mineral Industries

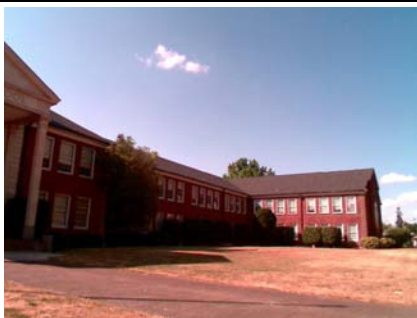
SE Plan Irregularity Primary

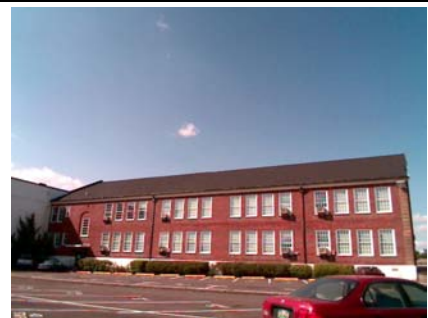
S Plan Irregularity Secondary

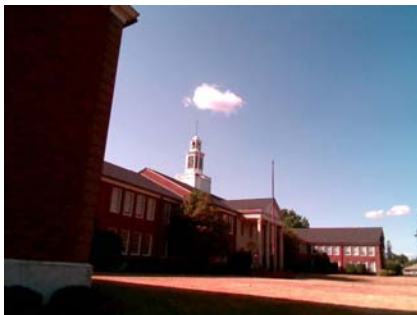
SE Falling Hazard

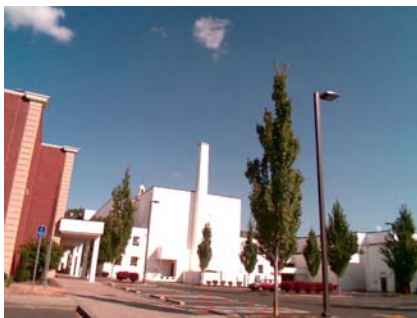
W Falling Hazard

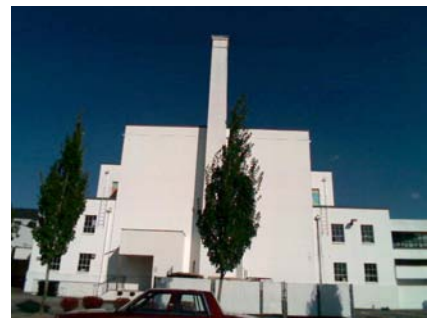
W Vertical Irregularity Primary

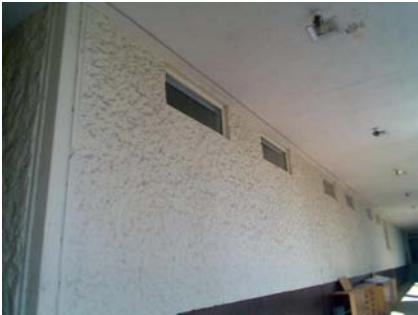
SW Primary Structural Type  
CONC CAST AROUND STL COLS

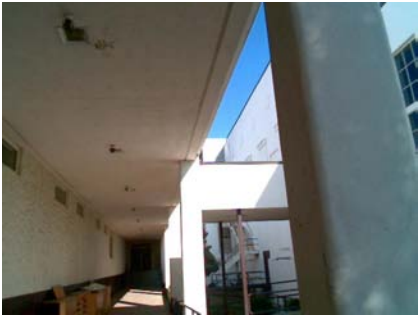
W Falling Hazard

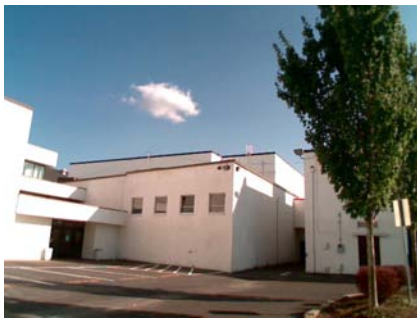
NW Vertical Irregularity Secondary

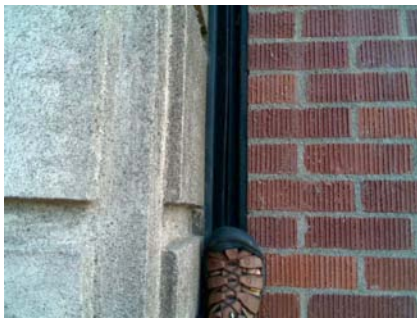
N Seismic Upgrade  
SEISMIC JT

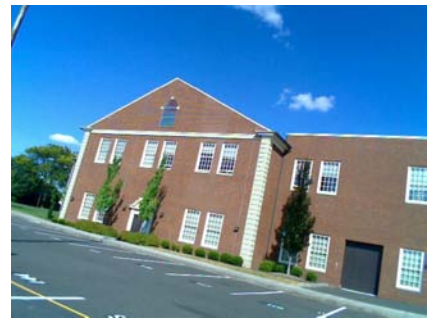
W Plan Irregularity Primary

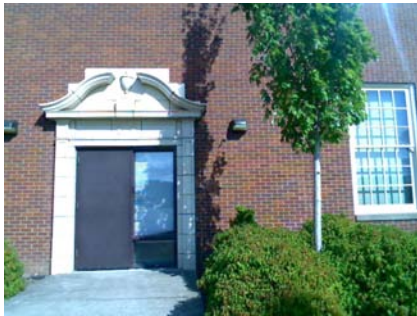
W Falling Hazard

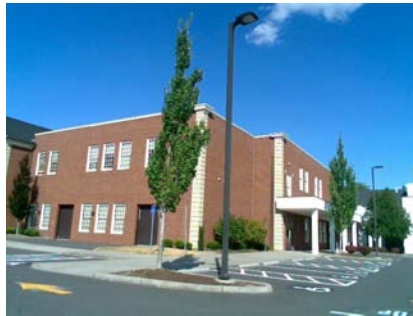
SW Plan Irregularity Primary

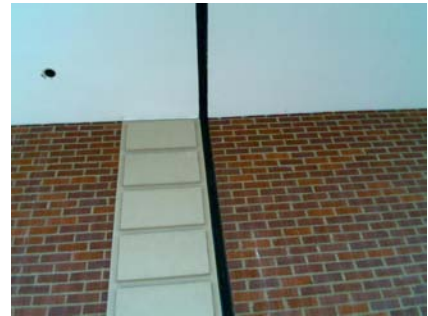
S Seismic Upgrade  
SEISMIC JT

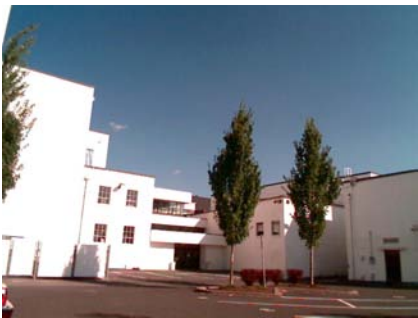
W Vertical Irregularity Primary

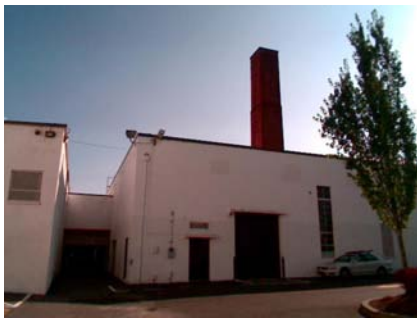
N Vertical Irregularity Secondary

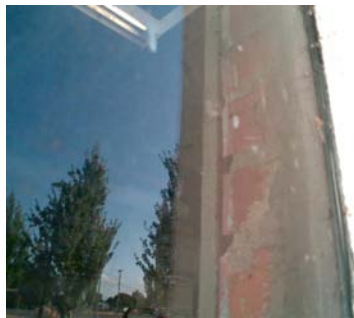
N Primary Structural Type  
URM VISIBLE IN THE BOILER RM WINDOW

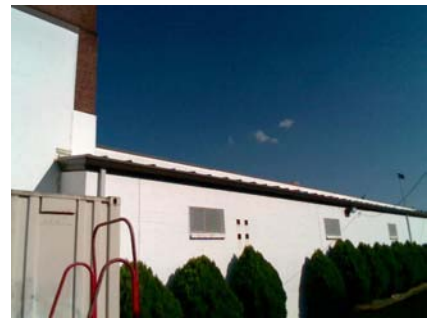
W Vertical Irregularity Primary
