Brooks Elementary School

Mari_sch47A

FEMA 154 Rapid Visual Screening Score Card

Rapid Visual Screening - Senate Bill #2 - Seismic Needs Assessment
Oregon Department of Geology and Mineral Industries

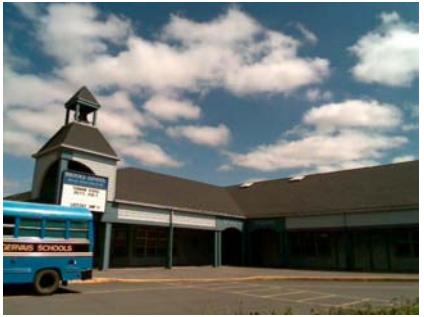
SW Plan Irregularity Primary

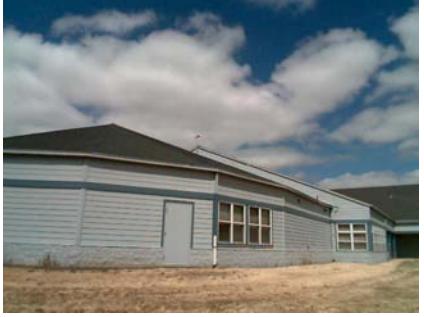
SE Vertical Irregularity Primary

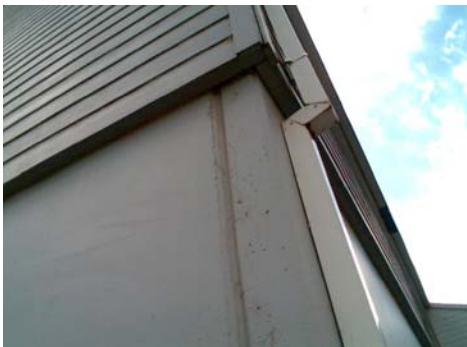
NW Secondary Structural Type
ON GYM

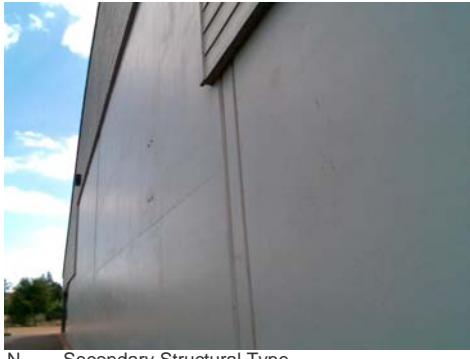
N Secondary Structural Type
PC1 ON GYM WALL - THIN MEMB IS STL TUBE COL
