Gervais Middle School

Mari_sch48A

FEMA 154 Rapid Visual Screening Score Card

Rapid Visual Screening - Senate Bill #2 - Seismic Needs Assessment
Oregon Department of Geology and Mineral Industries

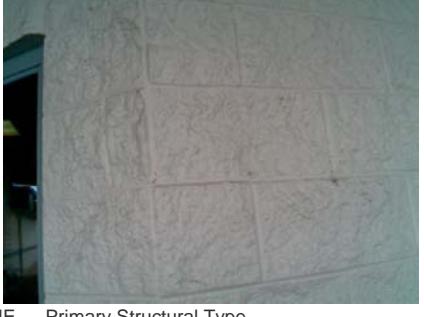
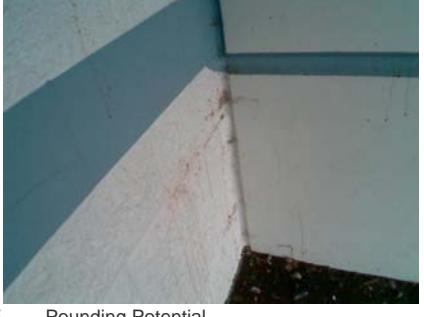
NE Primary Structural Type		E Pounding Potential Wall on right is PC1 and RM1

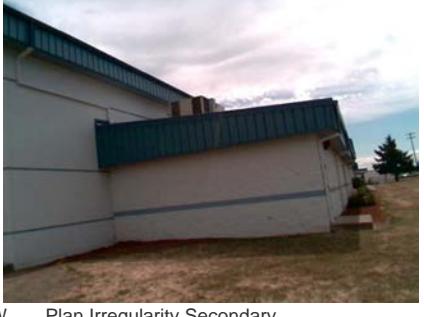
SW Elevation View		W Plan Irregularity Secondary

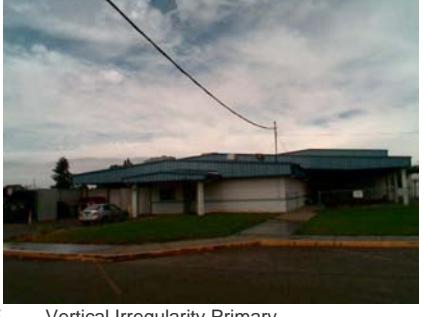
E Vertical Irregularity Primary

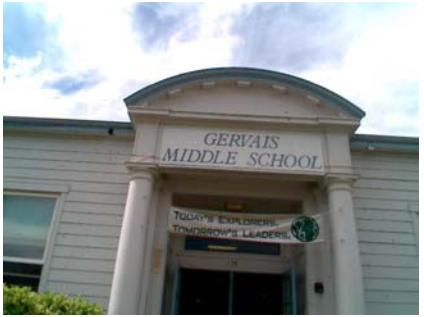
N Falling Hazard

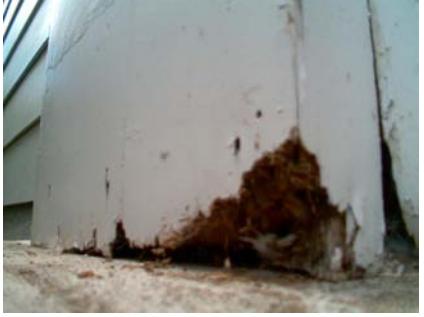
NW Poor Condition Dry rot

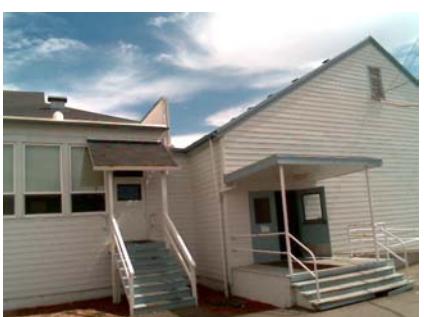
SW Vertical Irregularity Primary
