# Stayton Elementary School

North Santiam SD 29J

Mari\_sch49A

Rapid Visual Screening - Senate Bill #2 - Seismic Needs Assessment  
Oregon Department of Geology and Mineral Industries

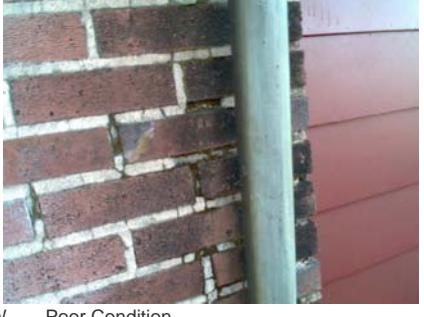
| W Poor Condition | S General Site | S Primary Structural Type<br>wood walls behind Brick | |

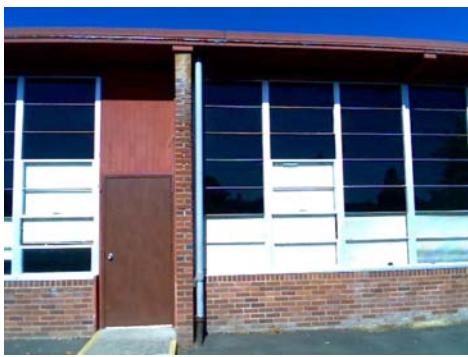
NE Poor Condition  
brick column shows deflection in middle.

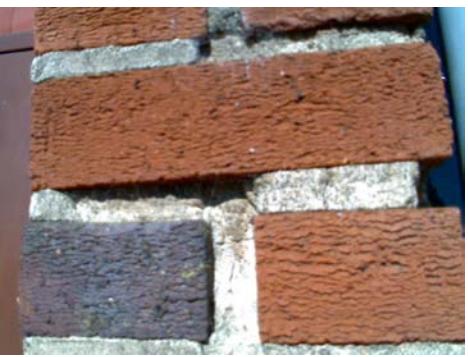
NE Poor Condition  
middle of brick column.  
Joint is 1/2" on one side. 3/4" on other. There is a large amount  
of bowing

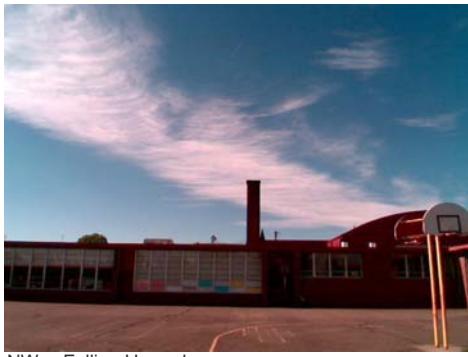
NW Falling Hazard  
smoke stack

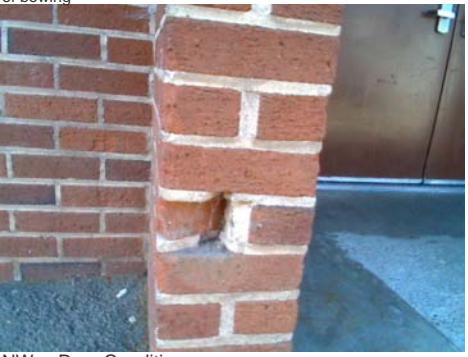
NW Poor Condition

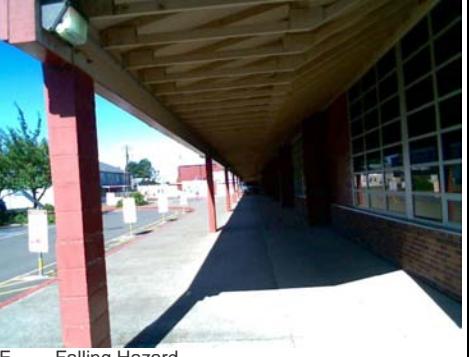
E Falling Hazard

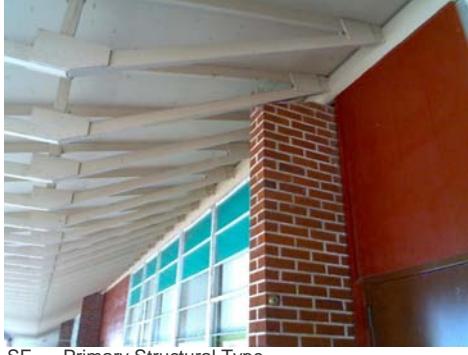
SE Primary Structural Type  
brick columns are not load bearing on front side (south) of bldg.

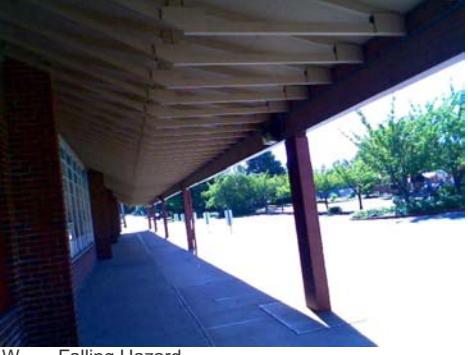
W Falling Hazard

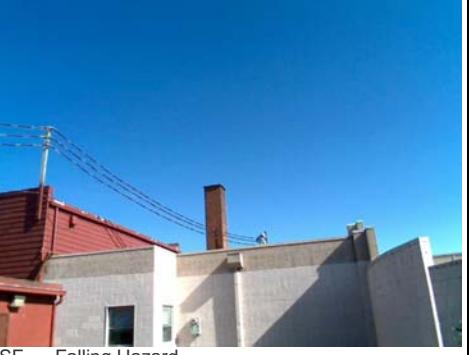
SE Falling Hazard
