# Stayton Middle School

Mari\_sch50A

## FEMA 154 Rapid Visual Screening Score Card

Rapid Visual Screening - Senate Bill #2 - Seismic Needs Assessment  
Oregon Department of Geology and Mineral Industries

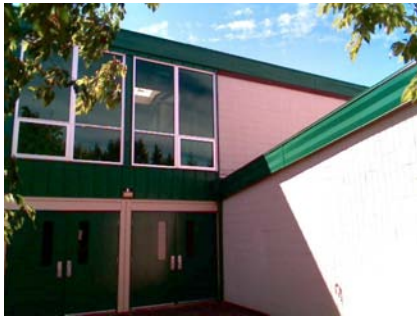
N Pounding Potential  
bldg D on left and A on right

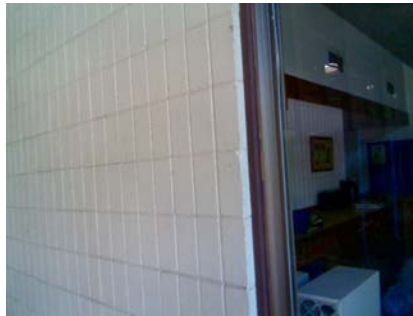
NW Primary Structural Type  
RM1

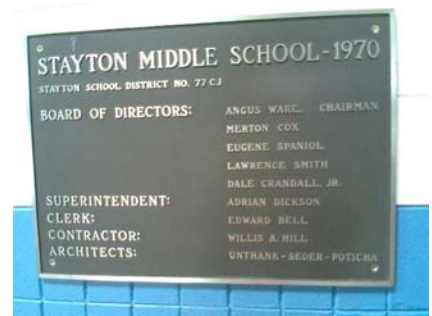
W Field Verified Year Built  
1970

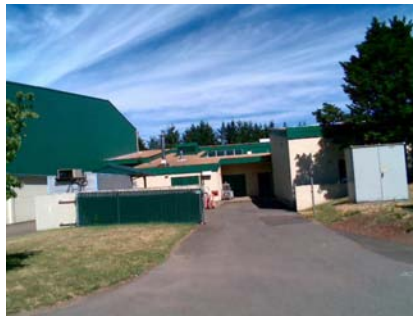
W Vertical Irregularity Primary

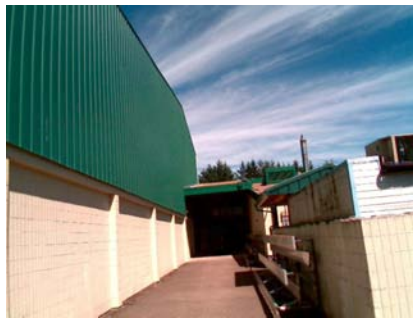
W Vertical Irregularity Primary

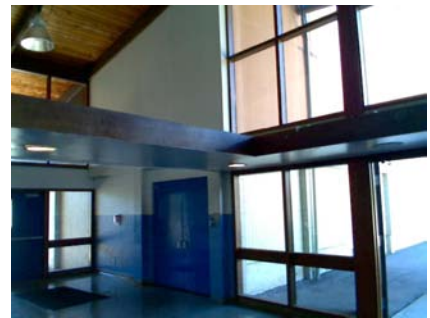
E General Site  
this is from inside bldg A looking at B. The two buildings meet at the corner with a little over lap, see plan view.

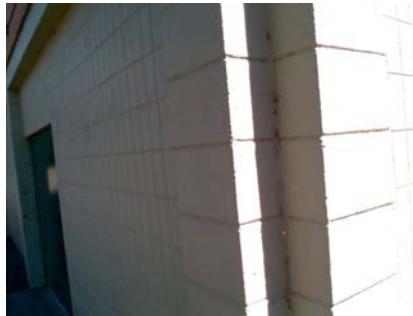
W Primary Structural Type  
RM1
