Turner Elementary School

Mari_sch51A

FEMA 154 Rapid Visual Screening Score Card

Rapid Visual Screening - Senate Bill #2 - Seismic Needs Assessment
Oregon Department of Geology and Mineral Industries

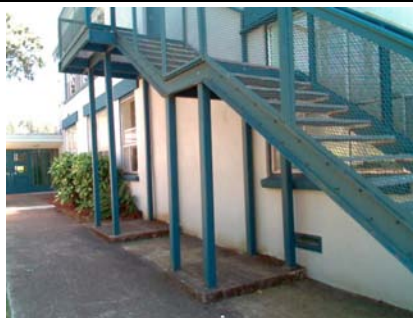
W Falling Hazard

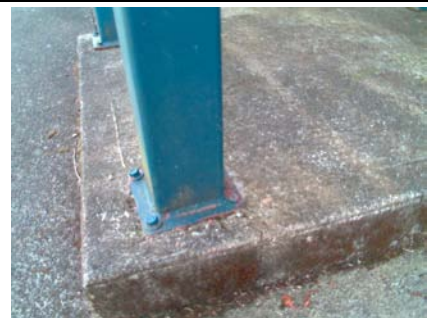
NW Falling Hazard

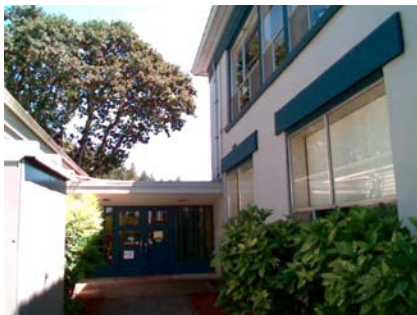
NW Pounding Potential

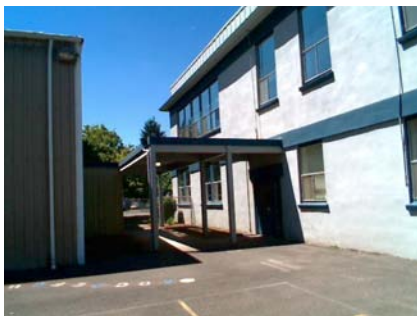
E Falling Hazard

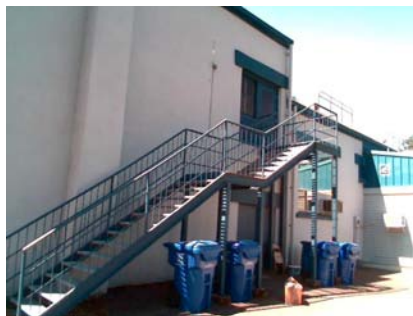
SE Falling Hazard

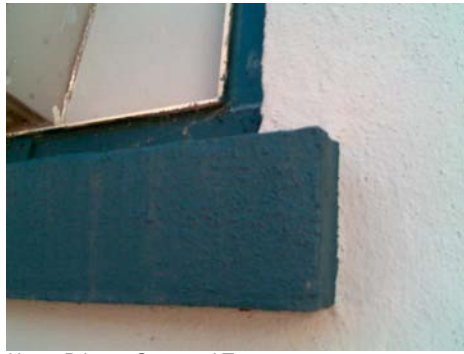
N Primary Structural Type

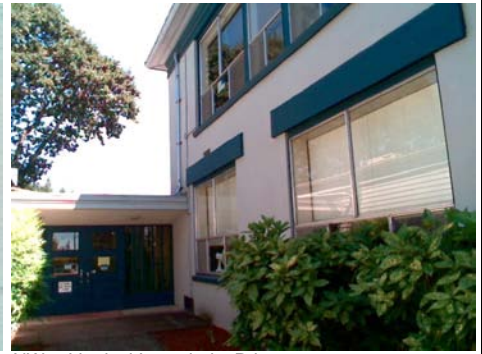
Plan Irregularities	Vertical Irregularities
Reentrant Corners: Other	Steps in Elevation View: 2 to 3 Changes
None	Steps in Elevation View: 2 to 3 Changes (Adjacent Building/Entity)
None	None

NW Vertical Irregularity Primary

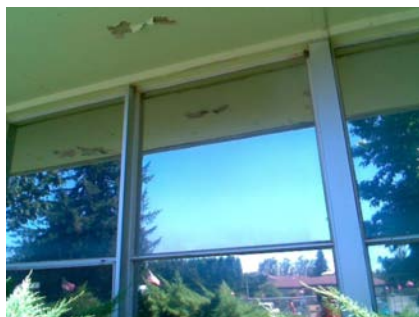
SW Building Quality

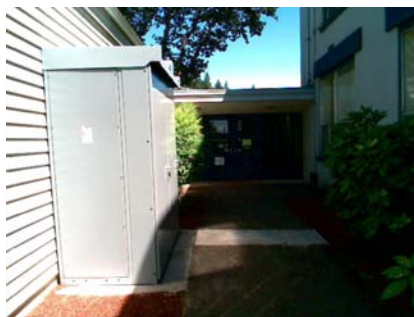
SW Pounding Potential

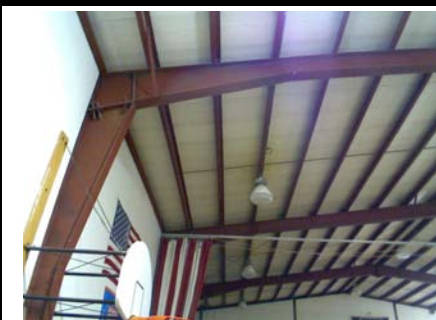
W Primary Structural Type
