Gervais High School

Mari_sch58A

FEMA 154 Rapid Visual Screening Score Card

Rapid Visual Screening - Senate Bill #2 - Seismic Needs Assessment
Oregon Department of Geology and Mineral Industries

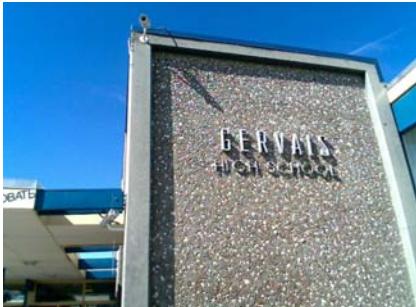
N
SE Elevation View	Building Name	Falling Hazard

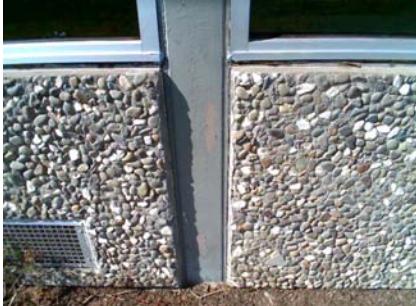
N
Primary Structural Type	Primary Structural Type	Primary Structural Type	
Steel columns with some concrete at base wood roof beam at the top of the steel.

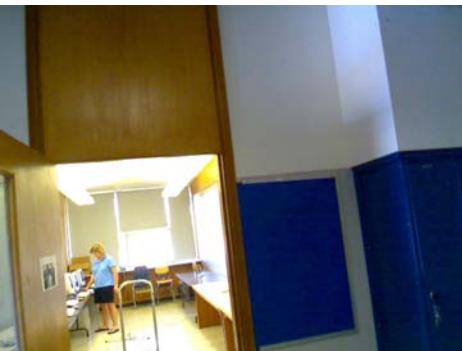
NE Primary Structural Type
drywall in the hallway, no shearwalls. Possible Lateral resistant
in one direction

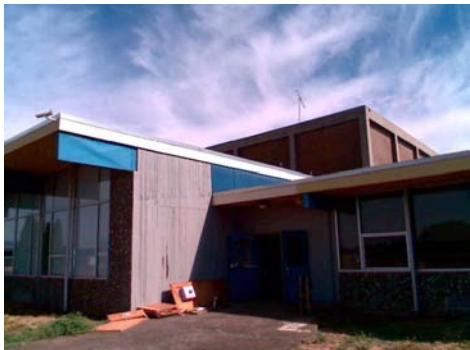
SE Vertical Irregularity Primary

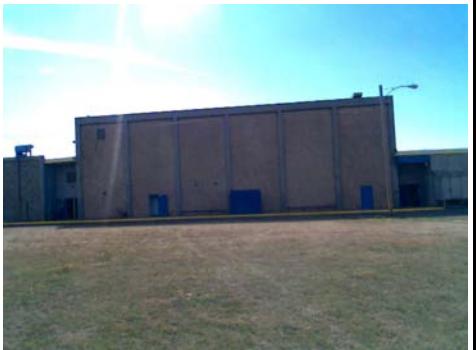
W Vertical Irregularity Secondary

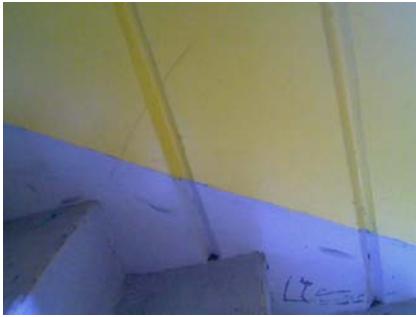
NE Primary Structural Type Solid Concrete seams no caulk
