# Cascade Junior High School

Mari\_sch60A

Rapid Visual Screening - Senate Bill #2 - Seismic Needs Assessment  
Oregon Department of Geology and Mineral Industries

Mari\_sch60B

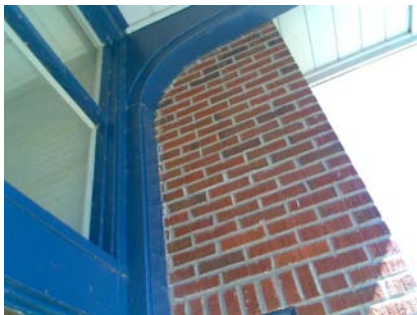
SW Primary Structural Type

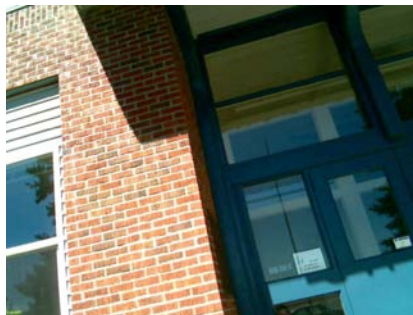
| Other: Brick Veneer | None |

SW Falling Hazard

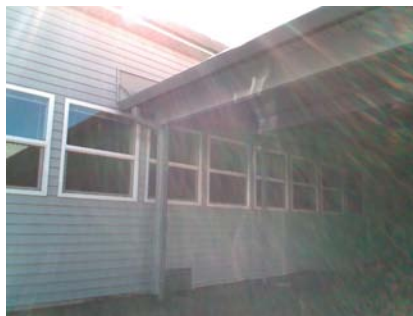
E Falling Hazard

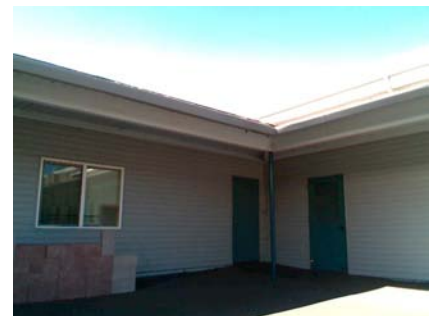
S Falling Hazard

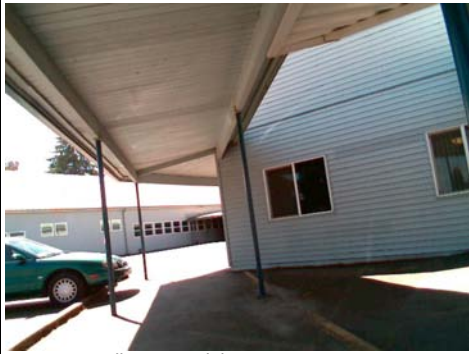
E Pounding Potential  
and falling

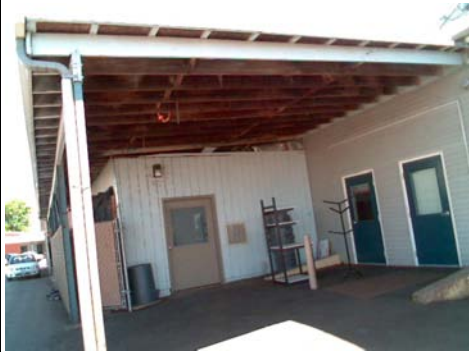
W Falling Hazard

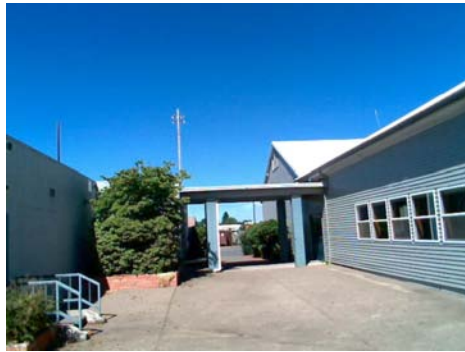
W Pounding Potential

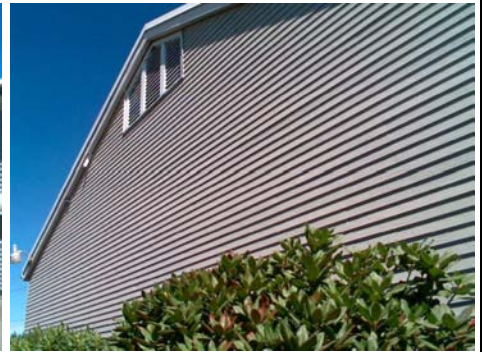
NW Primary Structural Type

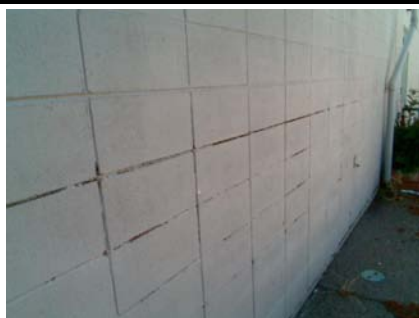
S Primary Structural Type
