Cascade Senior High School

Mari_sch61A

FEMA 154 Rapid Visual Screening Score Card

Rapid Visual Screening - Senate Bill #2 - Seismic Needs Assessment
Oregon Department of Geology and Mineral Industries

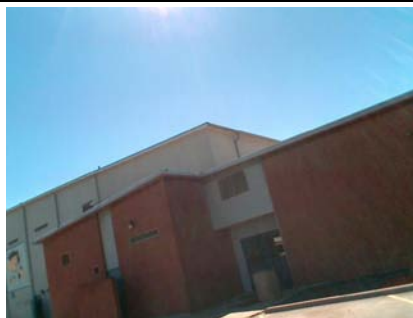
W Vertical Irregularity Primary

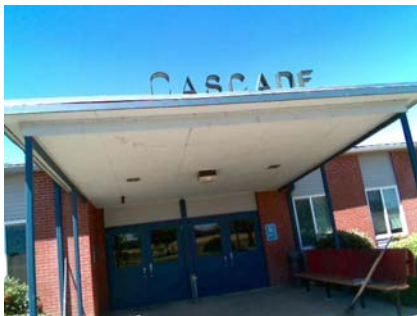
NE Falling Hazard

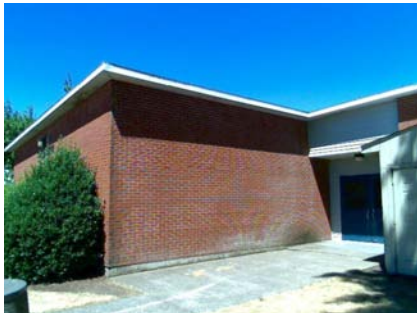
NE Falling Hazard
Brick

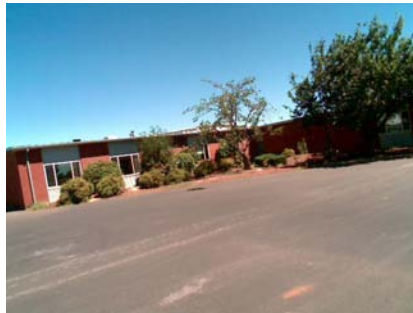
W Plan Irregularity Primary

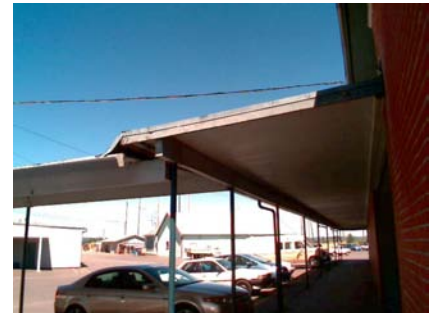
SE Pounding Potential
and falling hazard

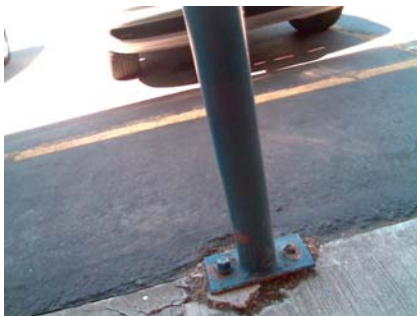
N Building Quality

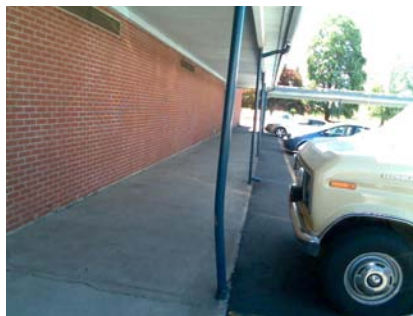
NW Falling Hazard
