Building Type		County	
School		Marion	
Street			
2450 Strong Rd SE			
City	State	Zip	
Salem	OR	97302	
Latitude		Longitude	
44.8931		123.00852	
Tracking Code		Inspection Date	
RVS in 2006		8/7/2006

FEMA 154 Rapid Visual Screening Score Card

Robert S Farrell High School

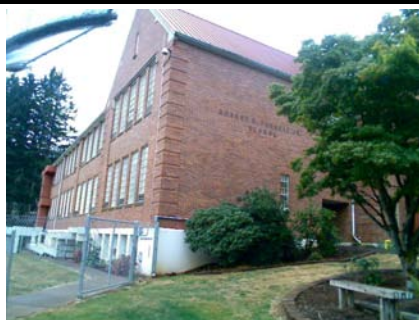
N Vertical Irregularity Primary

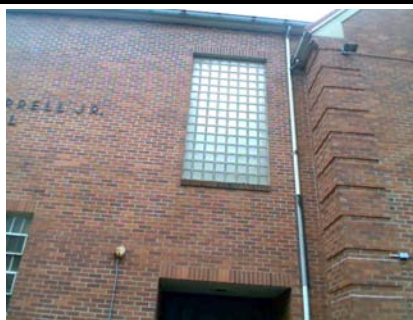
NW Other
BRICK VENEER

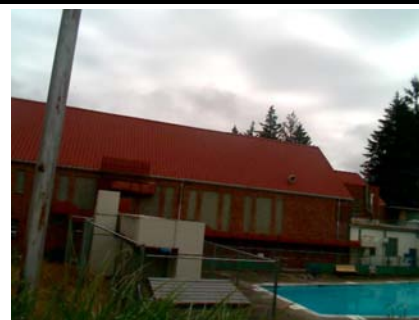
SW Vertical Irregularity Secondary

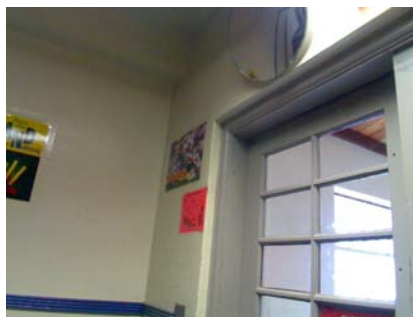
E Primary Structural Type
CONC STAIR WALL

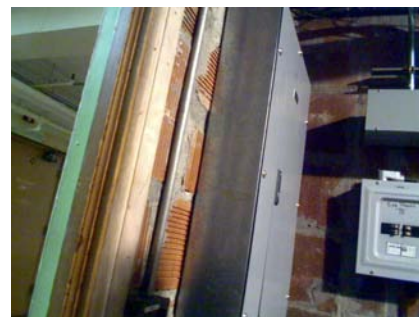
E Building Quality
HALL WALL IS CLAY TILE HERE

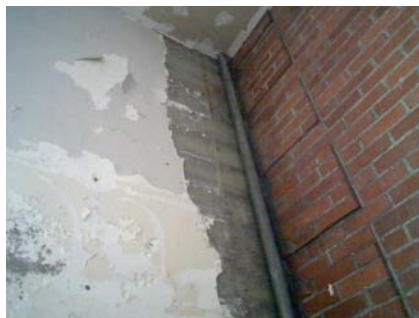
N Building Quality
ADDN TO MAIN BLDG - CONC WALL

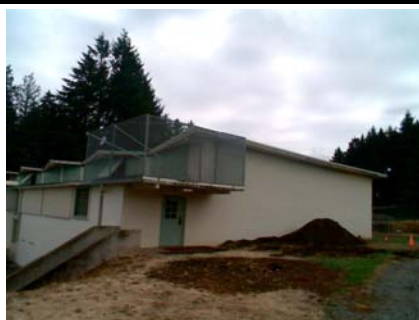
SW Vertical Irregularity Primary

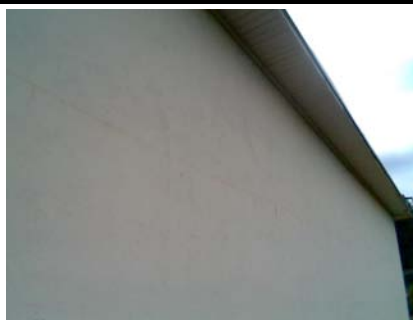
SW Primary Structural Type
6X6 TG CEDAR ROOF DECK PER REX EMORY

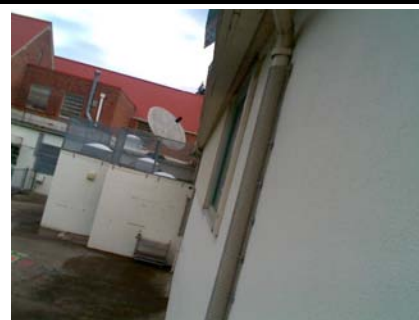
SW Secondary Structural Type
CMU ADDN AT POOLSIDE

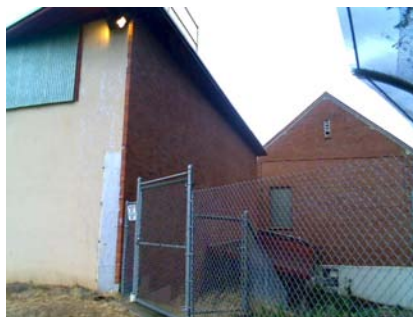
E Falling Hazard
BRICK VENEER AND HILLSIDE

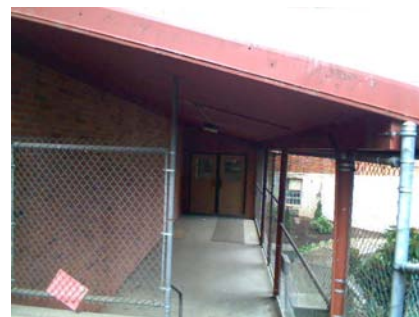
SE Falling Hazard

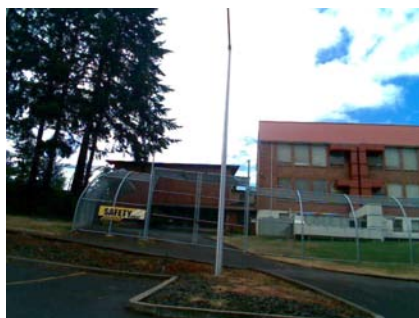
NE Vertical Irregularity Secondary
FROM BELOW AT ENTRY DRIVE
