Oregon School for the Deaf

Building Type	County	
School	Marion	
Street		
999 Locust St		
City	State	Zip
Salem	OR	97303
Latitude	Longitude	
44.96597	123.02334	
Tracking Code	Inspection Date	
RVS in 2006	7/20/2006

FEMA 154 Rapid Visual Screening Score Card

Rapid Visual Screening - Senate Bill #2 - Seismic Needs Assessment
Oregon Department of Geology and Mineral Industries

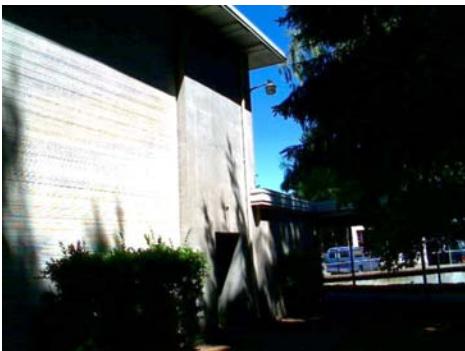
SW Pounding Potential

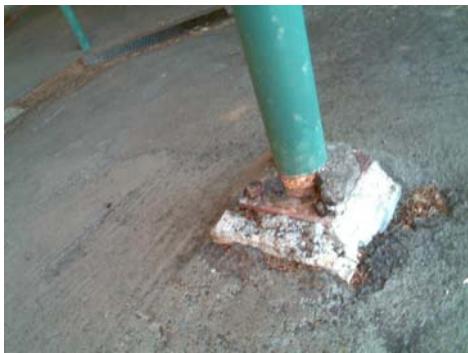
N Building Quality

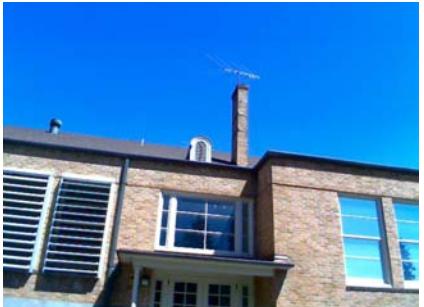
W Falling Hazard

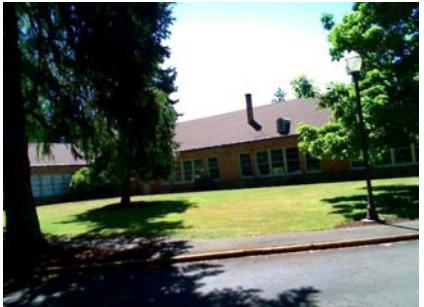
NE Falling Hazard

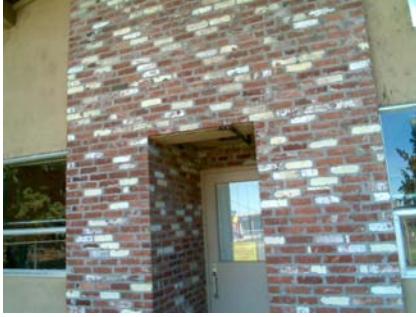
N General Site		N Falling Hazard

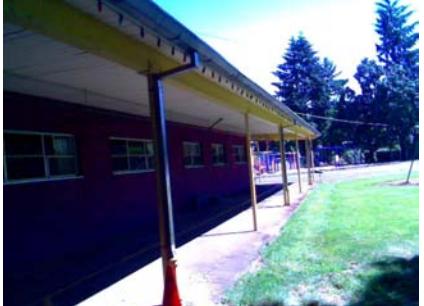
NW Falling Hazard

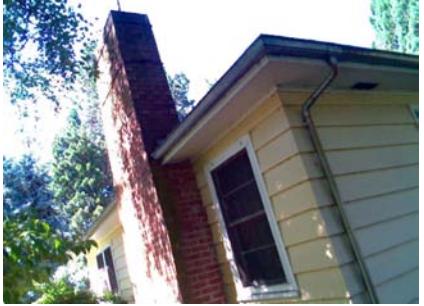
SE Falling Hazard

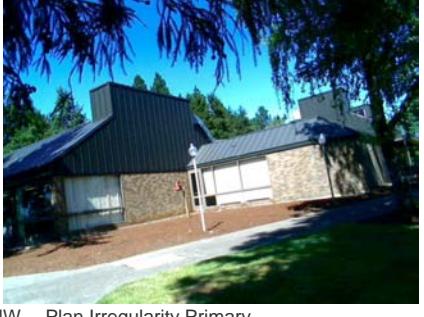
NW Plan Irregularity Primary

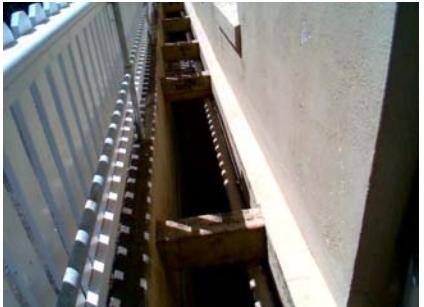
E Pounding Potential

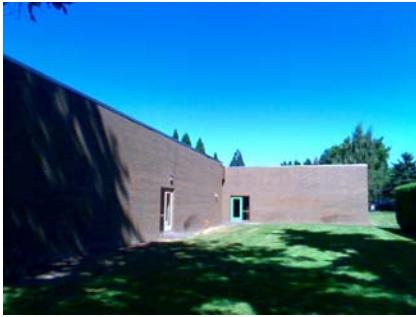
E Plan Irregularity Primary

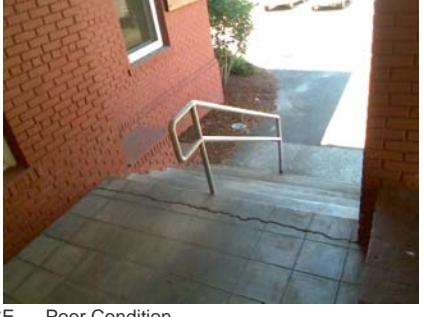
SE	Poor Condition
