William P Lord High School

Mari_sch94A

FEMA 154 Rapid Visual Screening Score Card

Rapid Visual Screening - Senate Bill #2 - Seismic Needs Assessment
Oregon Department of Geology and Mineral Industries

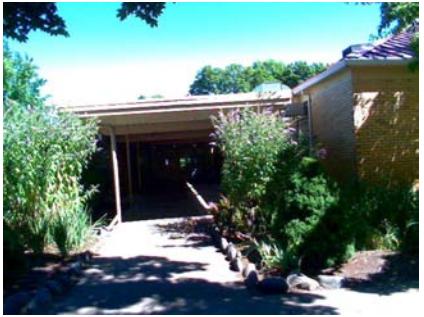
S Pounding Potential

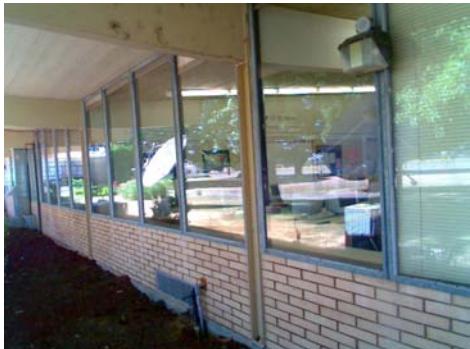
W Primary Structural Type
Steel colum support wooden beams

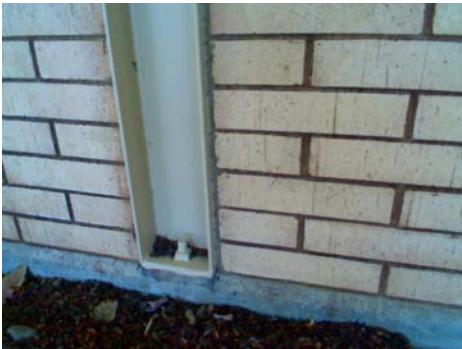
NW Primary Structural Type
Base of column

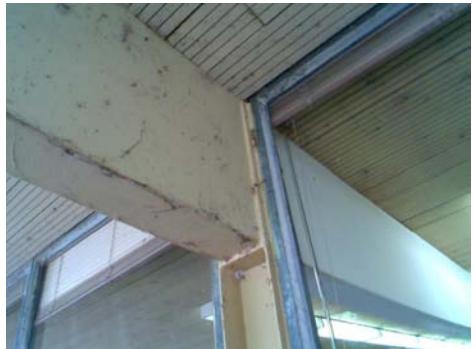
NW Primary Structural Type
Top of Column

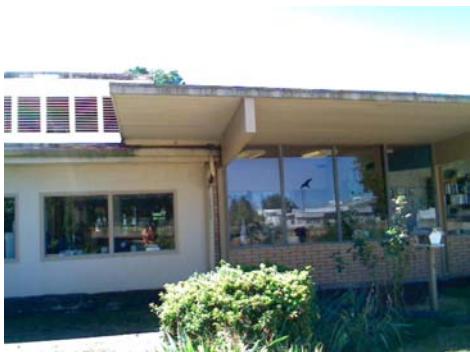
N Pounding Potential
bldg B on left A on right.

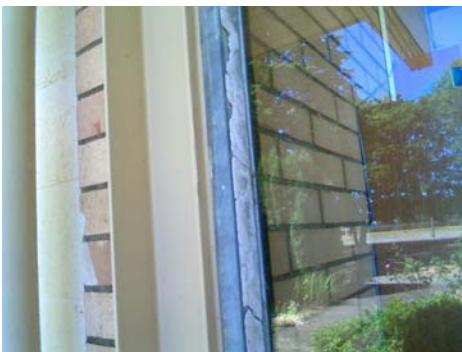
W Primary Structural Type
brick wall goes through building. There is about a 3 inch gap
between the brick walls, possibly rein

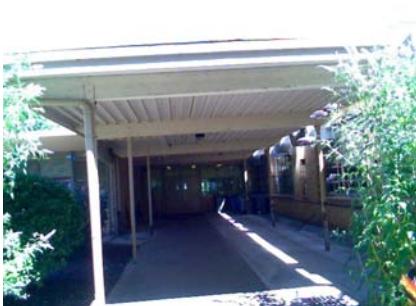
S Falling Hazard

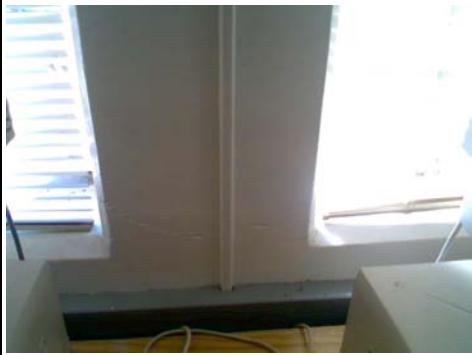
W Primary Structural Type
inside classroom Concrete column. Minor cracks where
columns meet wall.

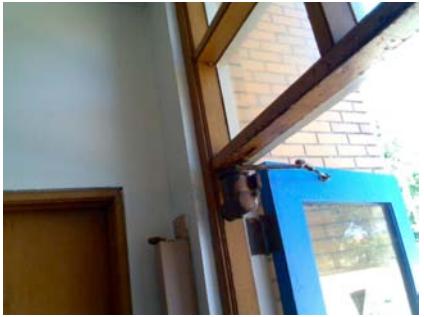
NE Primary Structural Type C2 walls on the left.

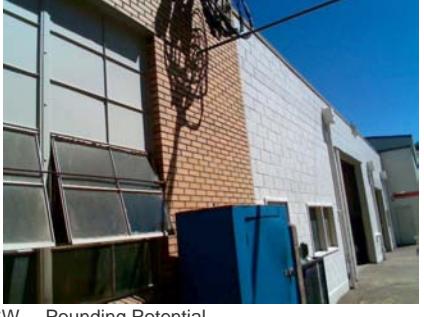
SW Pounding Potential mech bldg in back bldg D in front.

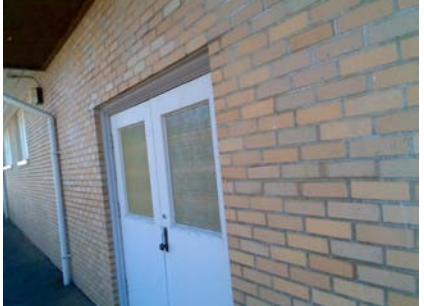
W Falling Hazard

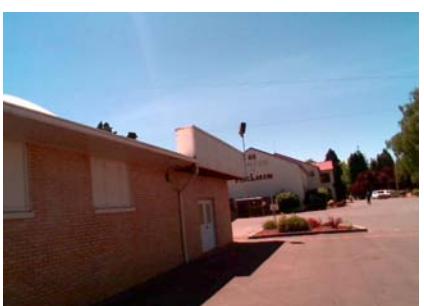
NW Falling Hazard
