Boardman RFPD

Morr_fir02A

Building Type Fire - RFPD	County Morrow	
Street 300 SW Wilson Ln		
City Boardman	State OR	Zip 97818
Latitude 45.82822	Longitude 119.70599	
Tracking Code RVS in 2006	Inspection Date 7/25/2006

FEMA 154 Rapid Visual Screening Score Card

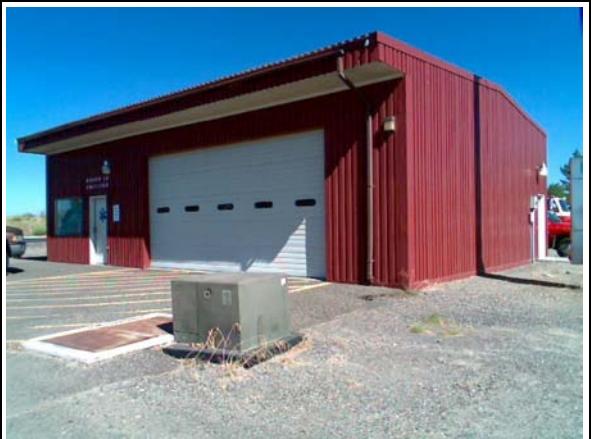
Morr_fir02B

Type	Basic Score	Vert Irreg	Plan Irreg	Pre-Code	Post-Bench	Soil C	Soil D	Soil E	RVS Score
Primary	S3	3.8	0	0	0	0	-0.6	0	0	3.2
Secondary		0	0	0	0	0	0	0	0	0
Tertiary		0	0	0	0	0	0	0	0	0

Final Type	Final Score
S3	3.2

Low (<1%)

Enrollment	Year Built (Field Verified)	Year Built (Alt. Source)	Est. Decade Built
			1990
Total Area (square ft)	Number of Stories	Basement	Pounding Potential
	1	No	No
Plan Irregularities		Vertical Irregularities	
None		None	
None		None	
None		None	
Falling Hazards		Poor Conditions	
None		None	
None		None	
None		None
