Ione School

Morr_sch05A

FEMA 154 Rapid Visual Screening Score Card

Rapid Visual Screening - Senate Bill #2 - Seismic Needs Assessment
Oregon Department of Geology and Mineral Industries

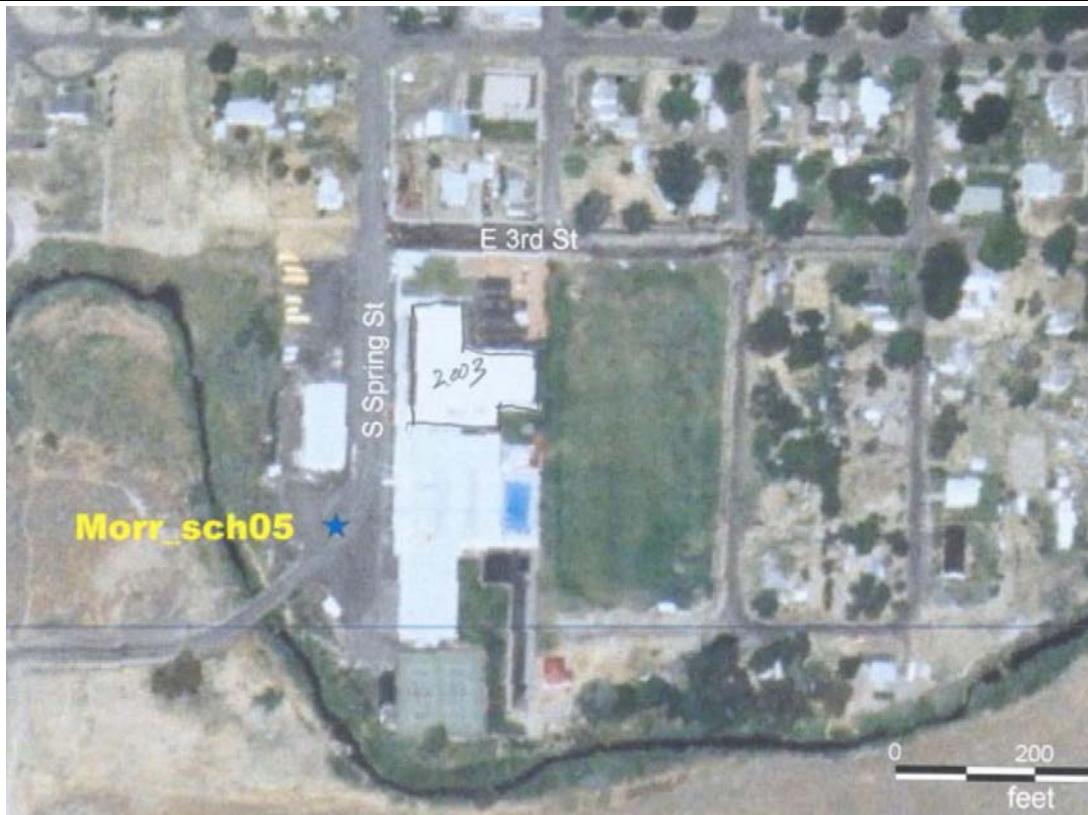
Type	Basic Score	Vert Irreg	Plan Irreg	Pre-Code	Post-Bench	Soil C	Soil D	Soil E	RVS Score
Primary	RM1	3.6	-2	-0.5	0	0	-0.8	0	0	0.3
Secondary	C2	3.6	-2	-0.5	0	0	-0.8	0	0	0.3
Tertiary		0	0	0	0	0	0	0	0	0

Final Type	Final Score
RM1	0.3

High (>10%)

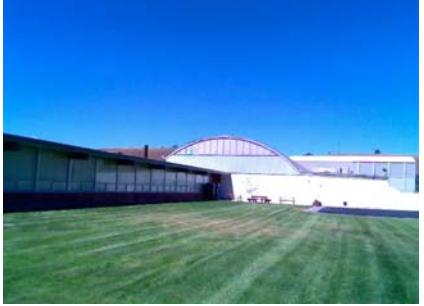
Enrollment 174	Year Built (Field Verified) 1961	Year Built (Alt. Source) 1961	Est. Decade Built 1960
Total Area (square ft) 55405	Number of Stories 1	Basement	Pounding Potential No
Plan Irregularities Reentrant Corners:L shaped (Adjacent Build/Entity) None None		Vertical Irregularities Steps in Elevation View: Single Change (Adjacent Building/Entity) None None	
Falling Hazards None None None		Poor Conditions None None None

S Vertical Irregularity Primary

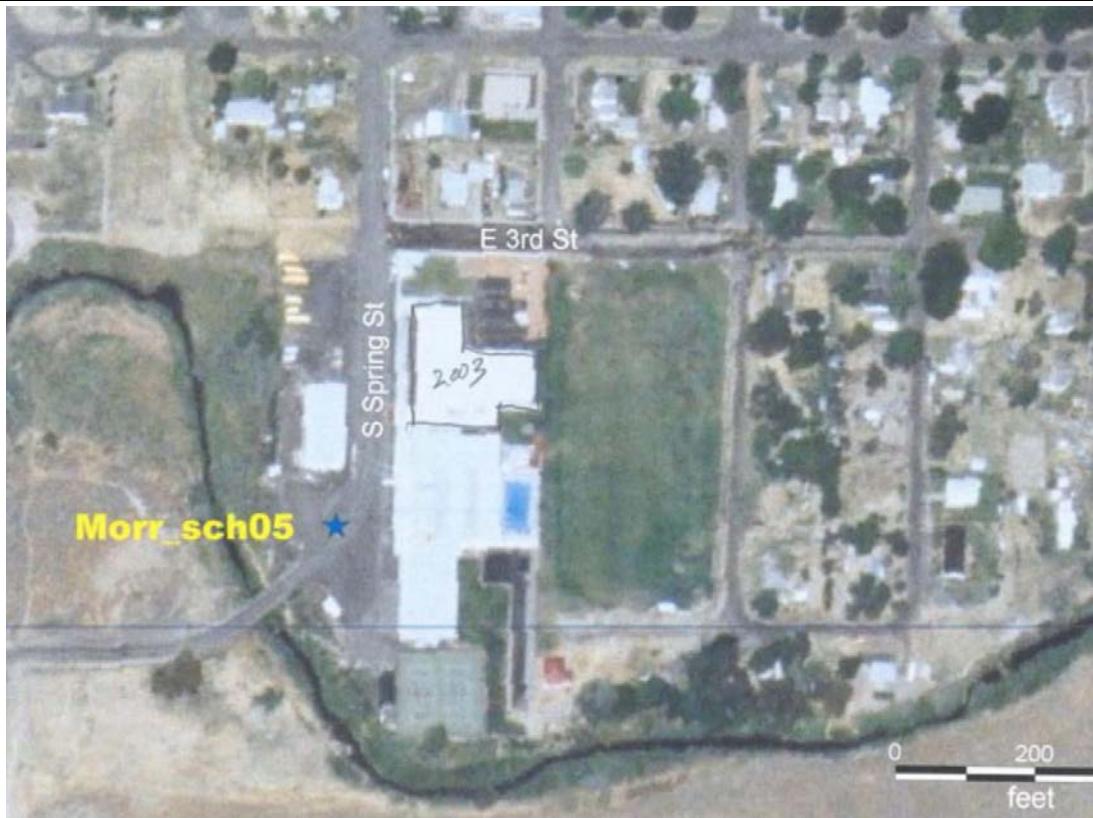
Type	Basic Score	Vert Irreg	Plan Irreg	Pre-Code	Post-Bench	Soil C	Soil D	Soil E	RVS Score
Primary	C2	3.6	-2	-0.5	0	0	-0.8	0	0	0.3
Secondary	RM1	3.6	-2	-0.5	0	0	-0.8	0	0	0.3
Tertiary		0	0	0	0	0	0	0	0	0

Final Type	Final Score
C2	0.3

High (>10%)

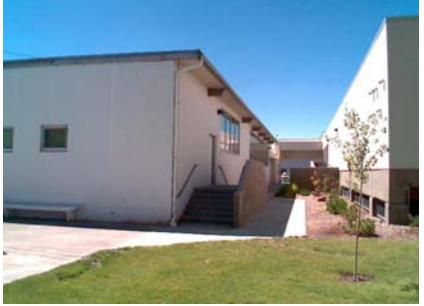
NE Elevation View

Enrollment 174	Year Built (Field Verified) 1961	Year Built (Alt. Source) 1961	Est. Decade Built 1960
Total Area (square ft) 55405	Number of Stories 1	Basement	Pounding Potential No
Plan Irregularities Reentrant Corners:L shaped (Adjacent Build/Entity) None None		Vertical Irregularities Steps in Elevation View: 2 to 3 Changes Steps in Elevation View: Single Change (Adjacent Building/Entity) None	
Falling Hazards None None None		Poor Conditions None None None
