Irrigon Junior/Senior High School

Morr_sch07A

FEMA 154 Rapid Visual Screening Score Card

Rapid Visual Screening - Senate Bill #2 - Seismic Needs Assessment
Oregon Department of Geology and Mineral Industries

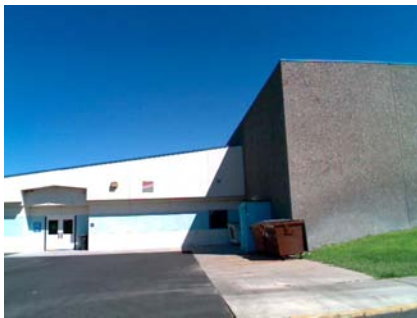
SE Plan Irregularity Secondary

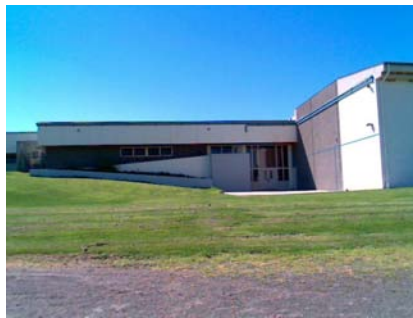
N Vertical Irregularity Secondary

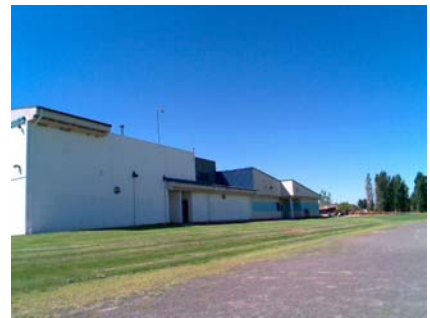
NE Vertical Irregularity Secondary

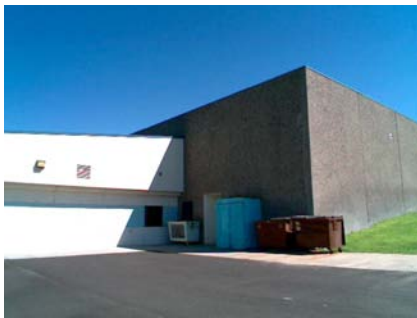
S Vertical Irregularity Primary

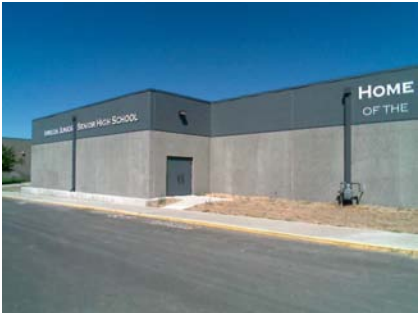
SE Plan Irregularity Primary
