Mt Hood CC

Mult_coc12A

FEMA 154 Rapid Visual Screening Score Card

Rapid Visual Screening - Senate Bill #2 - Seismic Needs Assessment
Oregon Department of Geology and Mineral Industries

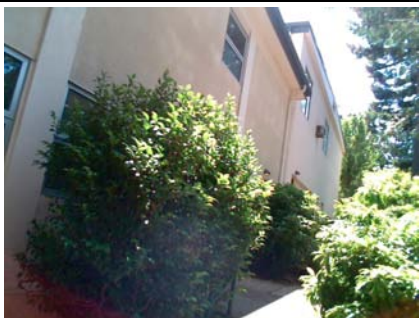
NW Vertical Irregularity Primary

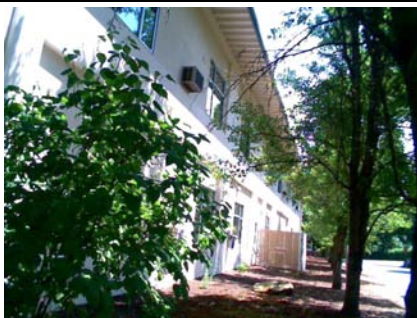
S Elevation View

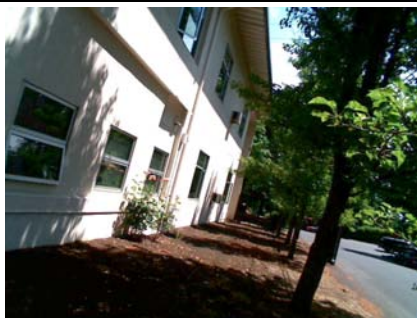
S Elevation View

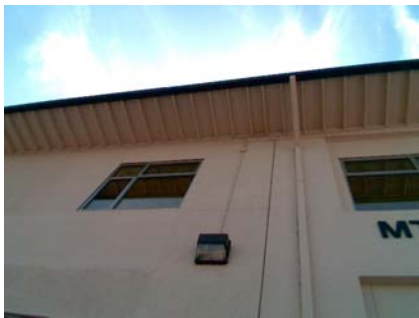
N Other
LINE BET A AND C

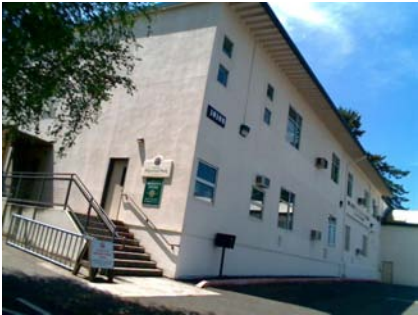
NE Elevation View

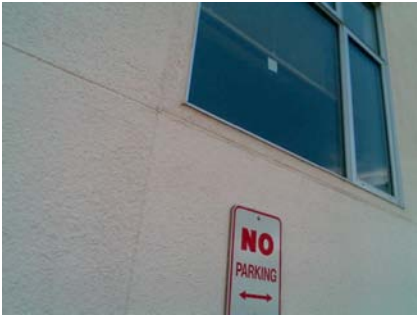
N Primary Structural Type
