Cascade - Student Services

Portland CC

FEMA 154 Rapid Visual Screening Score Card

Rapid Visual Screening - Senate Bill #2 - Seismic Needs Assessment
Oregon Department of Geology and Mineral Industries

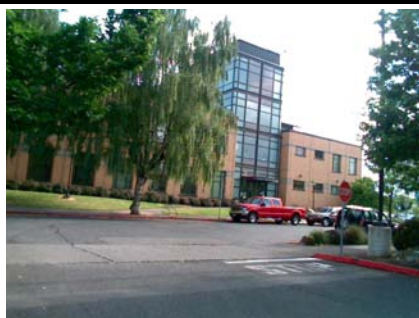
NE Vertical Irregularity Primary
