Providence Portland Medical Center

Mult_hos01A

FEMA 154 Rapid Visual Screening Score Card

Rapid Visual Screening - Senate Bill #2 - Seismic Needs Assessment
Oregon Department of Geology and Mineral Industries

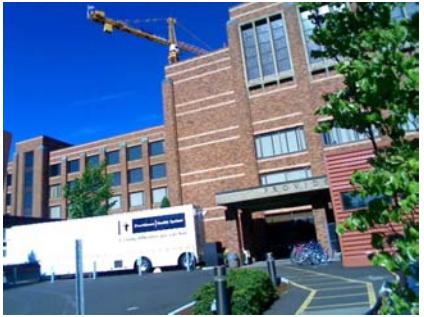
W	General Site	W	Falling Hazard

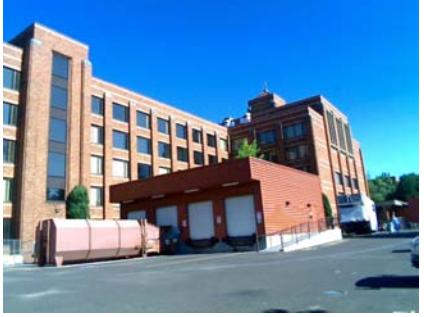
NW	Plan Irregularity Primary	NW	Plan Irregularity Secondary

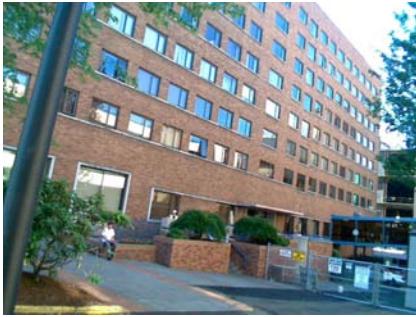
SE Elevation View		E Falling Hazard

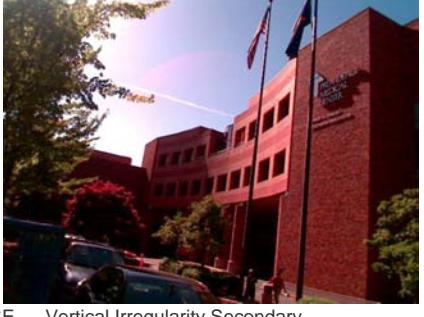
SE	Vertical Irregularity Secondary	S	Falling Hazard

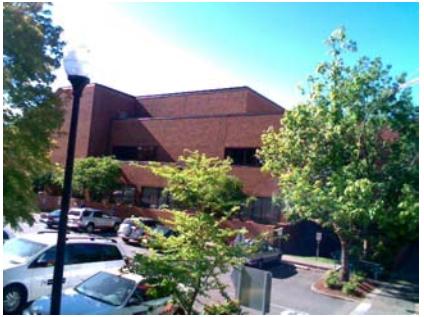
SE Vertical Irregularity Primary		SW Elevation View
