OHSU Hospital

Mult_hos04A

FEMA 154 Rapid Visual Screening Score Card

Rapid Visual Screening - Senate Bill #2 - Seismic Needs Assessment
Oregon Department of Geology and Mineral Industries

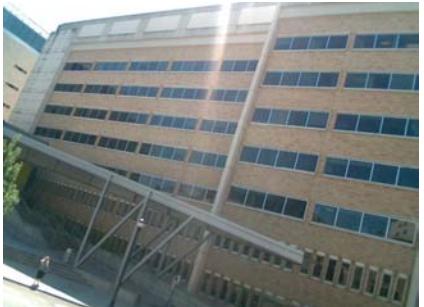
N Plan Irregularity Secondary

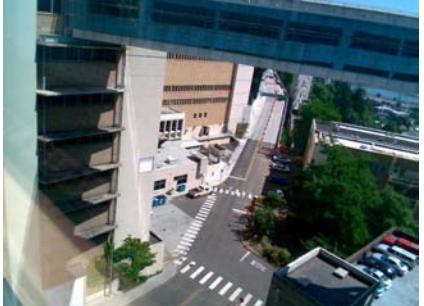
S Seismic Upgrade

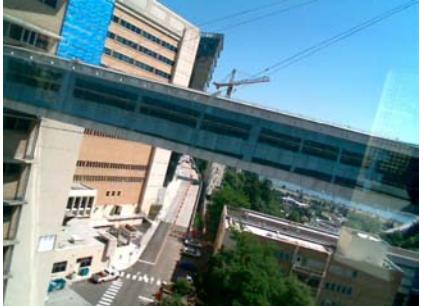
S Plan Irregularity Primary

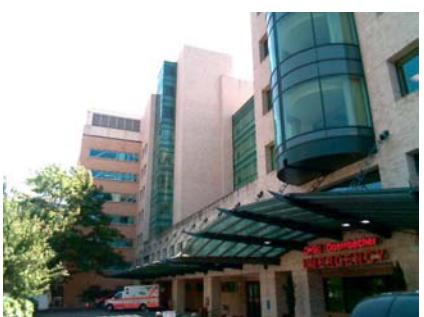
NW Seismic Upgrade
STEEL BRACES CAN BE OBSERVED IN THE WINDOWS OF THE MAIN HOSPITAL

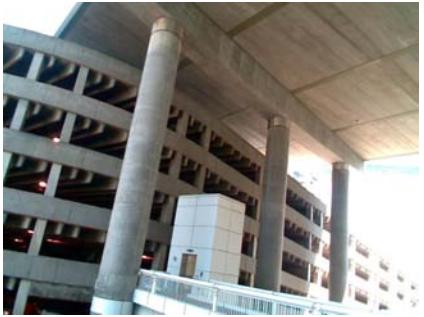
NW Primary Structural Type
