## Adventist Medical Center

## Mult hos06A

FEMA 154 Rapid Visual Screening Score Card

Rapid Visual Screening - Senate Bill #2 - Seismic Needs Assessment  
Oregon Department of Geology and Mineral Industries

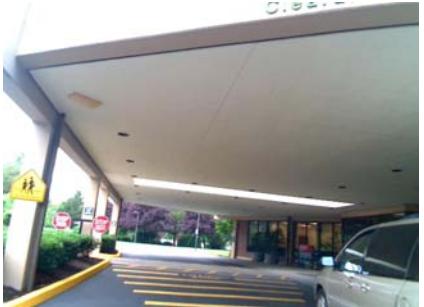
SW	Primary Structural Type	SW	Number of Stories

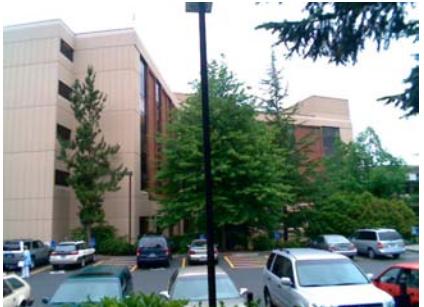
S Elevation View

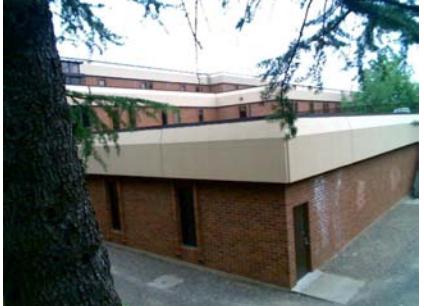
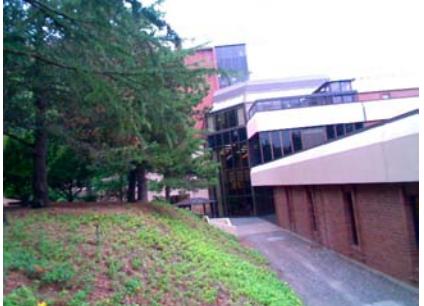
SW	Vertical Irregularity Primary	S	Vertical Irregularity Primary

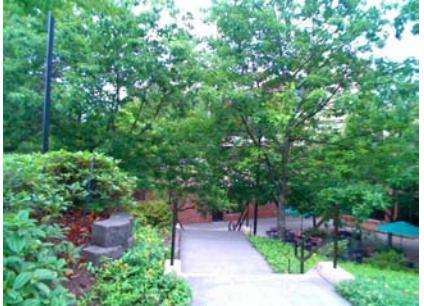
SE Vertical Irregularity Tertiary

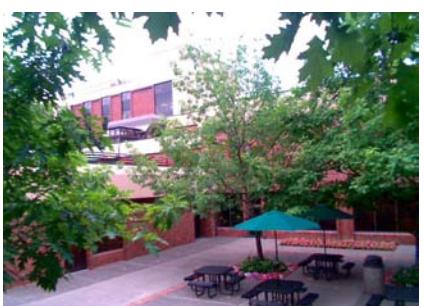
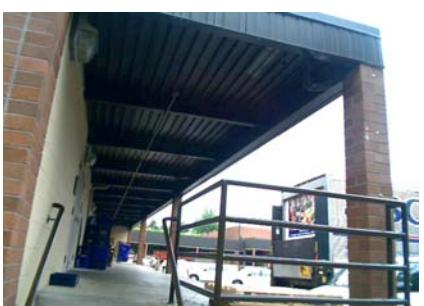
SE	Plan Irregularity Primary	S	Falling Hazard can also see cmu at dock

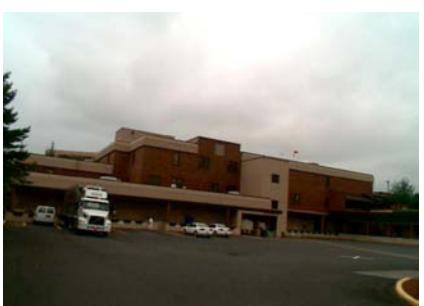
E Vertical Irregularity Primary

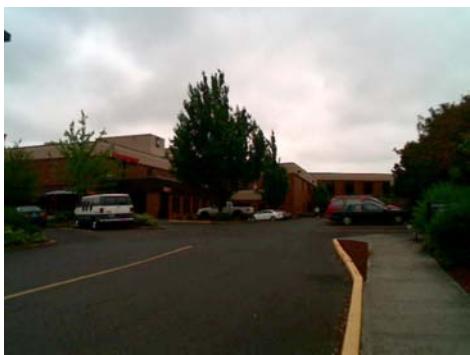
NE Plan Irregularity Primary

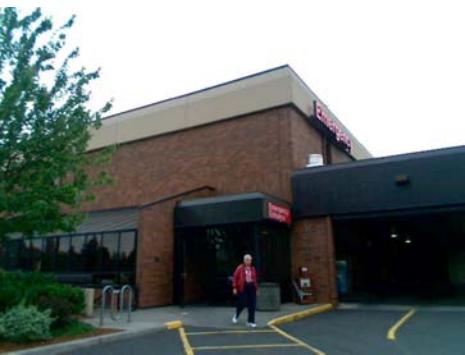
NE Tertiary Structural Type

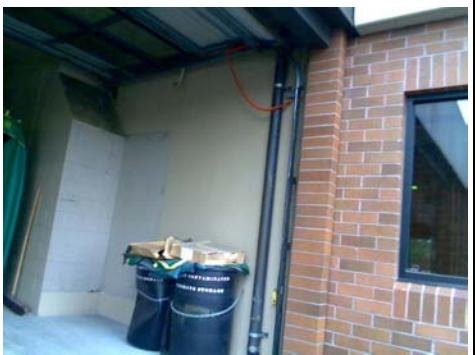
NE Secondary Structural Type

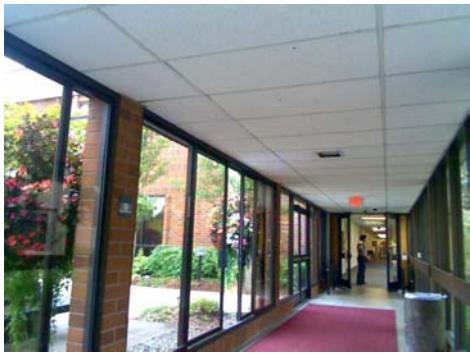
N Tertiary Structural Type

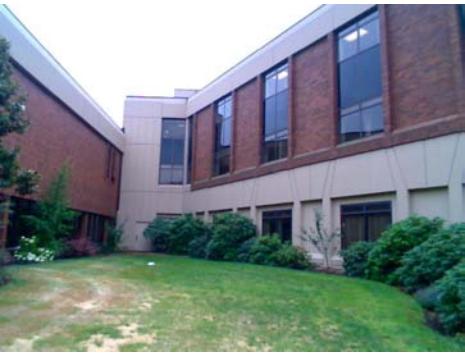
N Vertical Irregularity Secondary

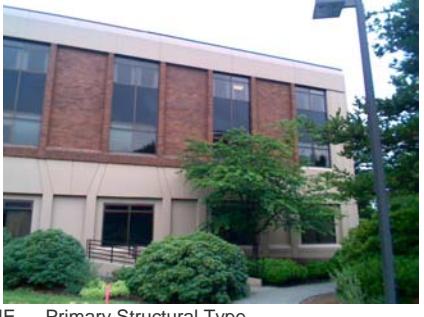
NE Primary Structural Type
