Legacy Good Samaritan Hospital

Mult_hos08A

Rapid Visual Screening - Senate Bill #2 - Seismic Needs Assessment
Oregon Department of Geology and Mineral Industries

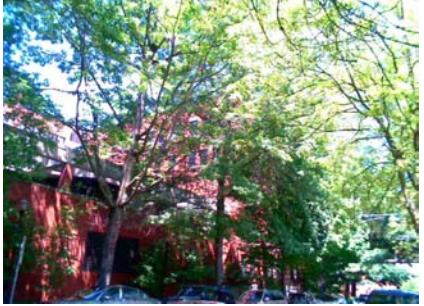
SW Elevation View		SW Falling Hazard

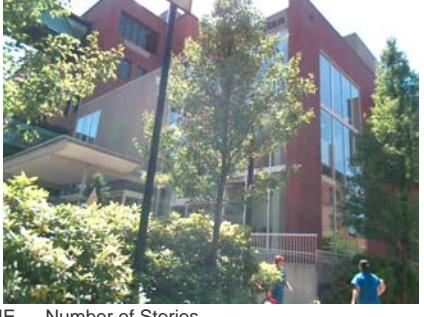
NE Number of Stories

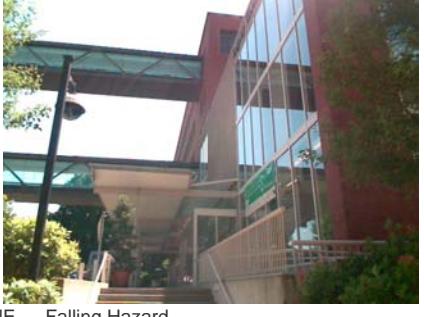
NE Falling Hazard

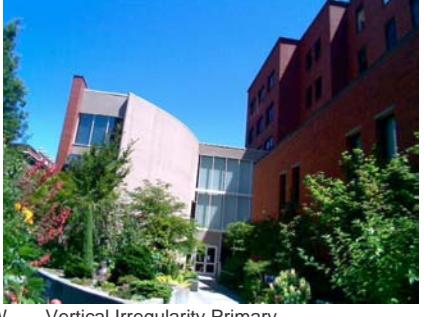
W Vertical Irregularity Primary
