# Portland Police Bureau Sunshine Division Office

## FEMA 154 Rapid Visual Screening Score Card

Rapid Visual Screening - Senate Bill #2 - Seismic Needs Assessment  
Oregon Department of Geology and Mineral Industries

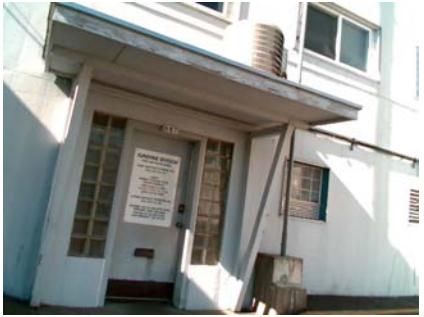
S	Falling Hazard	S	Building Name

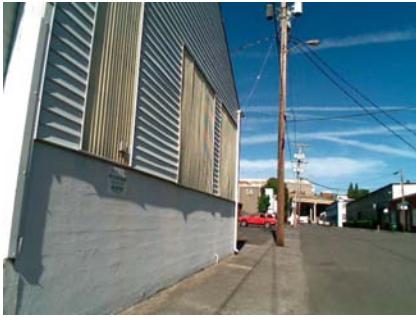
S	Primary Structural Type	SE	Elevation View

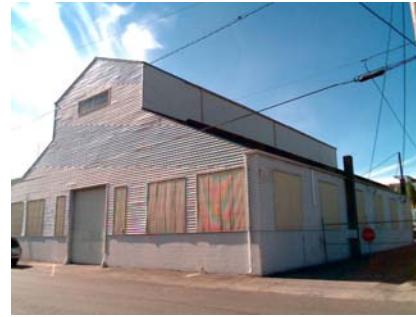
Enrollment	Year Built (Field Verified)	Year Built (Alt. Source)	Est. Decade Built
		1929	1910
Total Area (square ft)	Number of Stories	Basement	Pounding Potential
	2	No	Yes
Plan Irregularities		Vertical Irregularities	
Reentrant Corners:Other (Adjacent Build/Entity)		Steps in Elevation View: 2 to 3 Changes	
None		None	
None		None	
Falling Hazards		Poor Conditions	
Unreinforced Chimneys		None	
None		None	
None		None
