# Prescott Elementary School

Mult\_sch124A

## FEMA 154 Rapid Visual Screening Score Card

Rapid Visual Screening - Senate Bill #2 - Seismic Needs Assessment  
Oregon Department of Geology and Mineral Industries

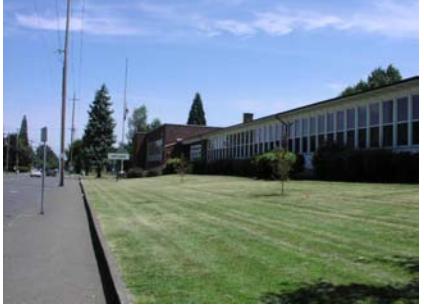
| <br>NW Plan Irregularity Primary | | <br>SW Elevation View | |

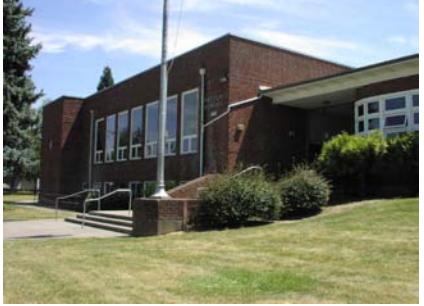
| <br>NW Plan Irregularity Primary | | <br>NE Plan Irregularity Primary | |

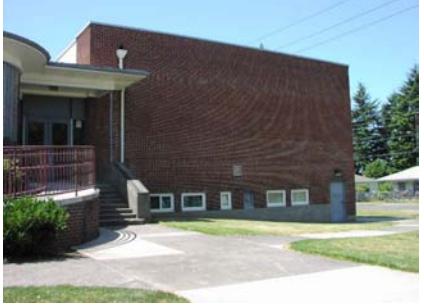
| <br>E Vertical Irregularity Primary | | <br>E Falling Hazard | |

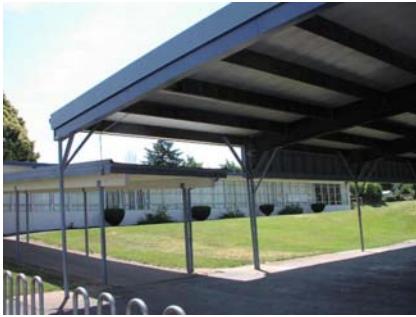
| N Falling Hazard | NE Primary Structural Type | SE Plan Irregularity Primary | |

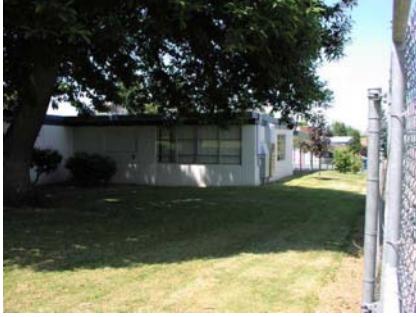
| SE Plan Irregularity Primary | S Plan Irregularity Primary | | |
