Shaver Elementary School

Parkrose SD 3

FEMA 154 Rapid Visual Screening Score Card

Rapid Visual Screening - Senate Bill #2 - Seismic Needs Assessment
Oregon Department of Geology and Mineral Industries

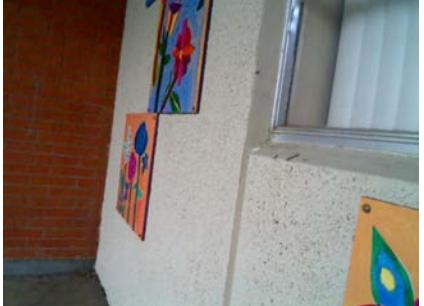
| E Primary Structural Type | | E Elevation View | |

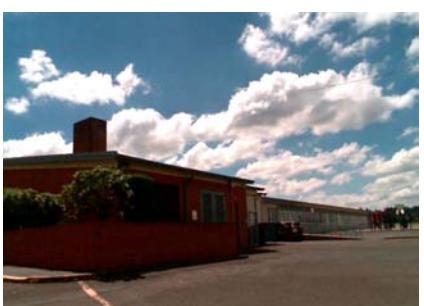
| NE Plan Irregularity Primary | | N Falling Hazard | |

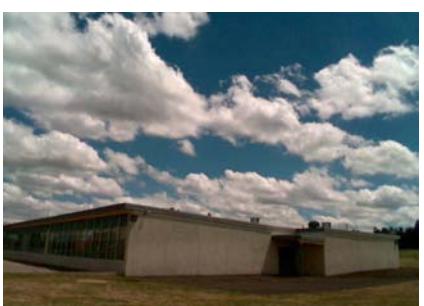
| | | NW Primary Structural Type | |

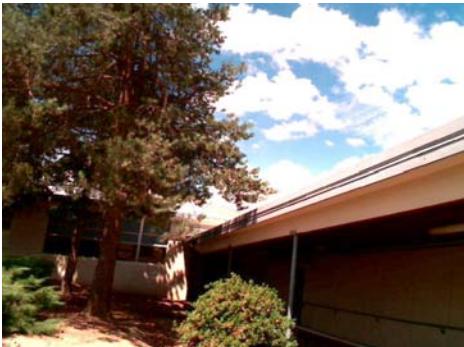
S Vertical Irregularity Primary

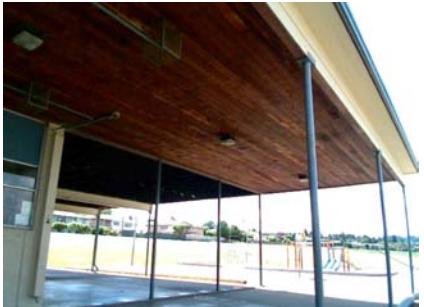
| N Falling Hazard | W General Site | SW Plan Irregularity Primary | |
