# Parkrose Middle School

Parkrose SD 3

## FEMA 154 Rapid Visual Screening Score Card

Rapid Visual Screening - Senate Bill #2 - Seismic Needs Assessment  
Oregon Department of Geology and Mineral Industries

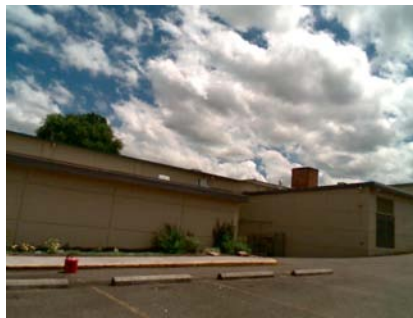
| Unreinforced Chimneys | None |

NW Falling Hazard

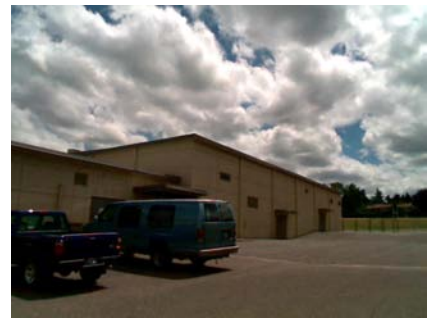
NW Falling Hazard

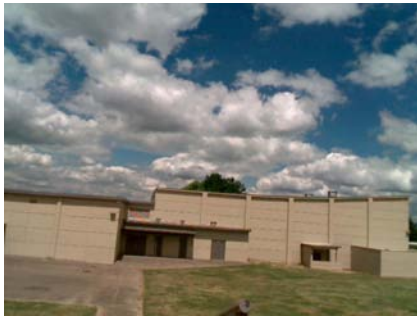
| Reentrant Corners: Other | Steps in Elevation View: Very Irregular Changes |

S Elevation View

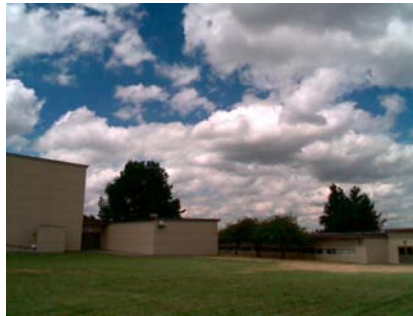
| Torsion: Eccentric Stiffness | Building On Hill or Sloped Site |

SE Plan Irregularity Primary

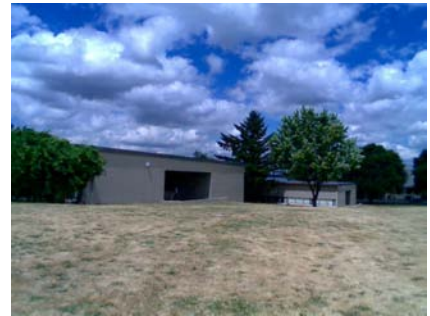
SE Plan Irregularity Primary

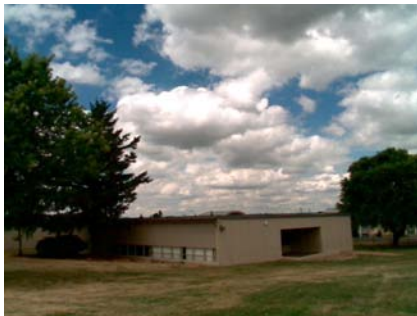
SE Plan Irregularity Secondary
