Fairview Elementary School

Mult_sch139A

FEMA 154 Rapid Visual Screening Score Card

Rapid Visual Screening - Senate Bill #2 - Seismic Needs Assessment
Oregon Department of Geology and Mineral Industries

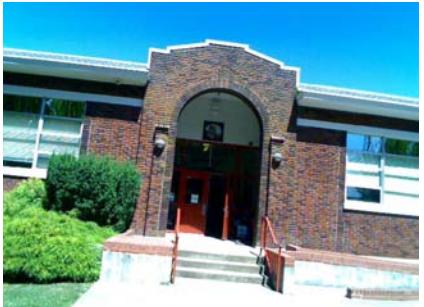
S Falling Hazard	S Field Verified Year Built

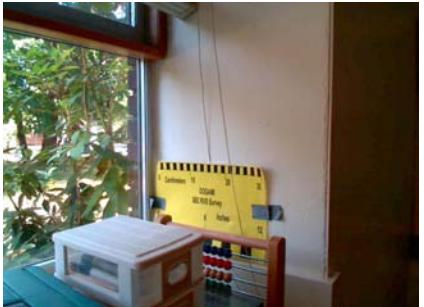
N Plan Irregularity Primary	NW Vertical Irregularity Primary

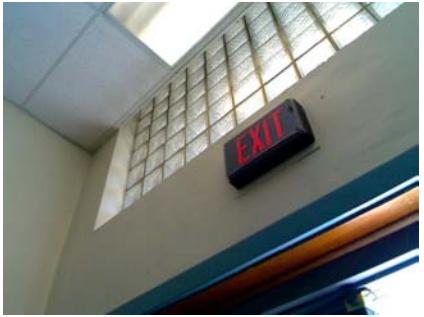
S Primary Structural Type C2 WALL		E Vertical Irregularity Secondary	
		NW Plan Irregularity Secondary

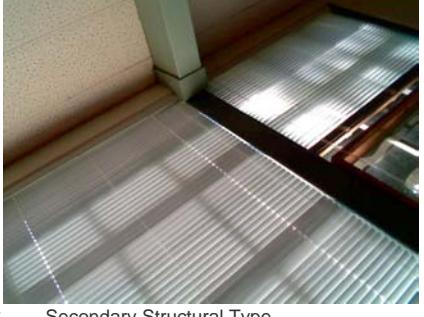
S Secondary Structural Type		NW Falling Hazard	SW Elevation View

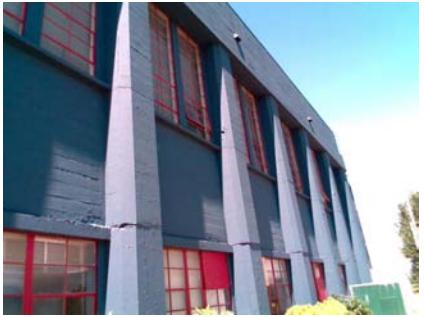
E Building Quality NOTE POUR BREAKS		NW Vertical Irregularity Secondary
