# Hauton B Lee Middle School

Mult\_sch147A

## FEMA 154 Rapid Visual Screening Score Card

Rapid Visual Screening - Senate Bill #2 - Seismic Needs Assessment  
Oregon Department of Geology and Mineral Industries

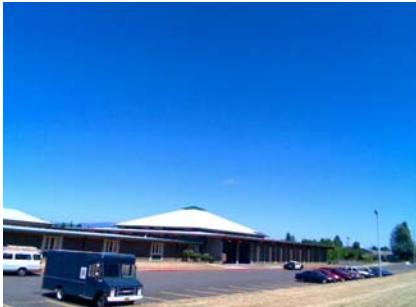
S Plan Irregularity Primary

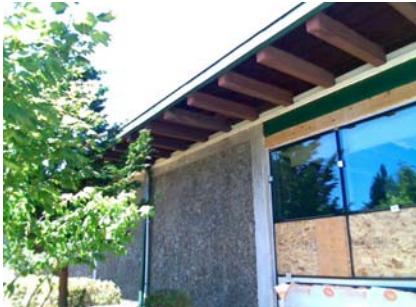
S Primary Structural Type

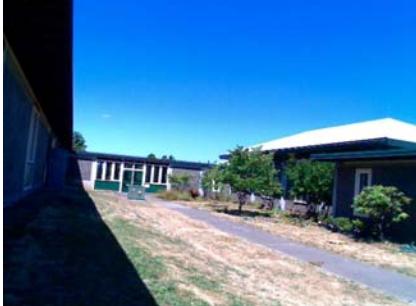
W Plan Irregularity Secondary

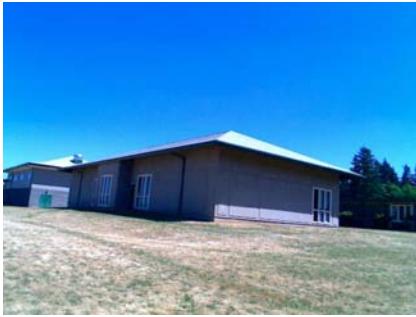
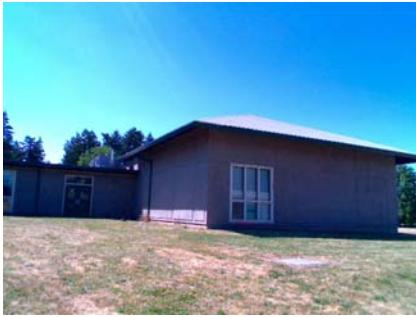
| NW Elevation View | | SE Plan Irregularity Primary | |

| Plan Irregularities<br>Reentrant Corners:Other (Adjacent Build/Entity)<br>None<br>None | | Vertical Irregularities<br>Steps in Elevation View: Single Change (Adjacent Building/Entity)<br>None<br>None | |

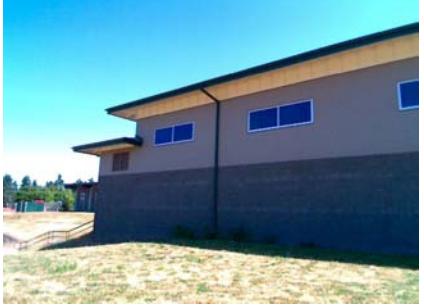
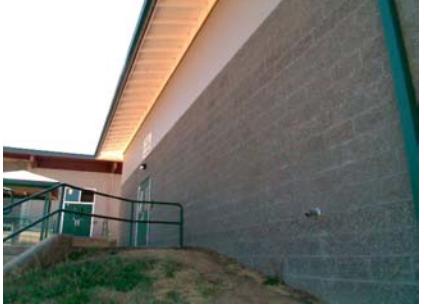
| <br>N General Site | | <br>E Elevation View<br>SLOPE AT NE CORNER IS 5 CMU COURSES | |
