## David Douglas SD 40

## FEMA 154 Rapid Visual Screening Score Card

Gilbert Park Elementary School

Rapid Visual Screening - Senate Bill #2 - Seismic Needs Assessment  
Oregon Department of Geology and Mineral Industries

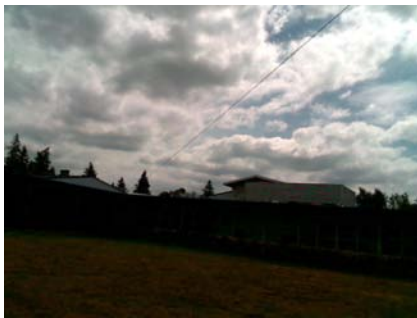
N Vertical Irregularity Primary

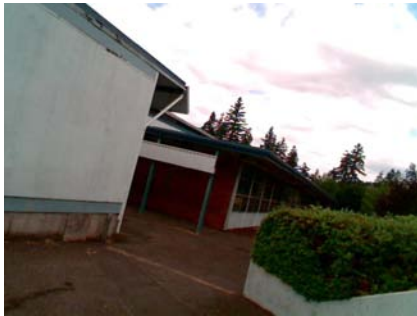
S Elevation View  
WOOD SIDED BLDG TO LEFT IS THE 2 ROOM CLASSROOM STRUCTURE

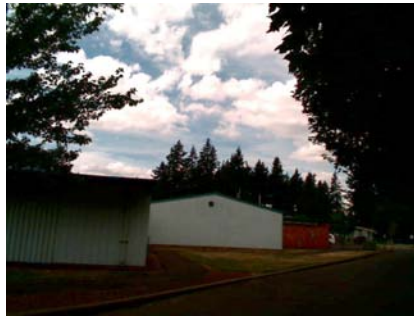
SE Plan Irregularity Primary  
T11 SIDING IS ON STORAGE BUMP-OUT

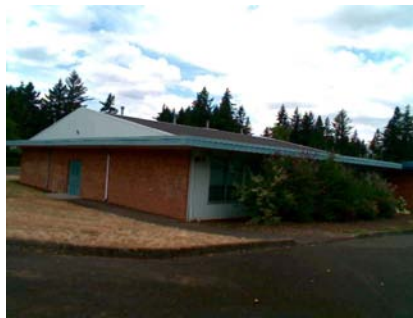
SW Vertical Irregularity Primary
