Harold Oliver Primary School Center

Centennial SD 28J

Mult_sch151A

Rapid Visual Screening - Senate Bill #2 - Seismic Needs Assessment
Oregon Department of Geology and Mineral Industries

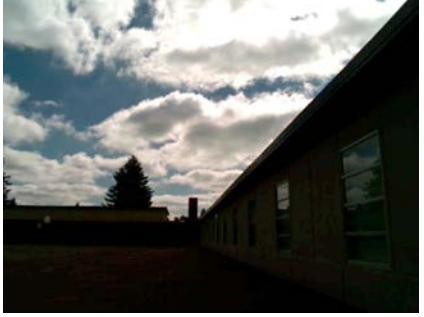
W Primary Structural Type	W Plan Irregularity Primary	W Falling Hazard CHIMNEY AND CANOPY

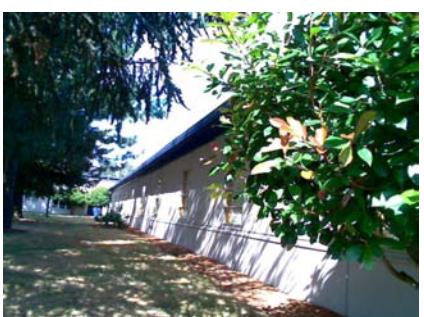
NE Elevation View	SE Elevation View	E Falling Hazard

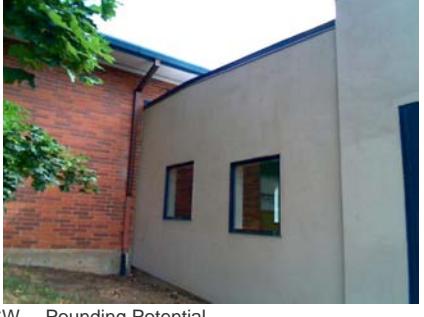
W Elevation View		SW Pounding Potential
