Lincoln Park Elementary School

David Douglas SD 40

FEMA 154 Rapid Visual Screening Score Card

Rapid Visual Screening - Senate Bill #2 - Seismic Needs Assessment
Oregon Department of Geology and Mineral Industries

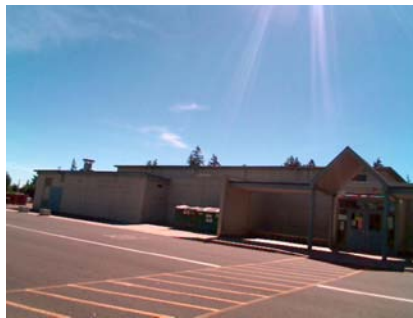
E Vertical Irregularity Primary

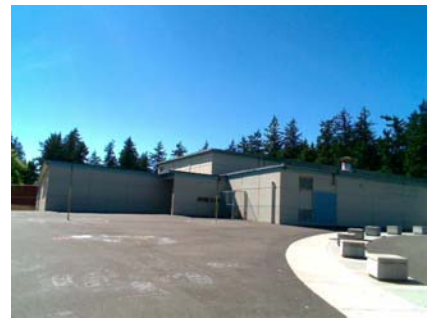
SE Vertical Irregularity Primary

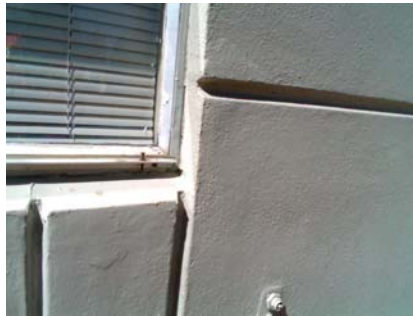
S Primary Structural Type

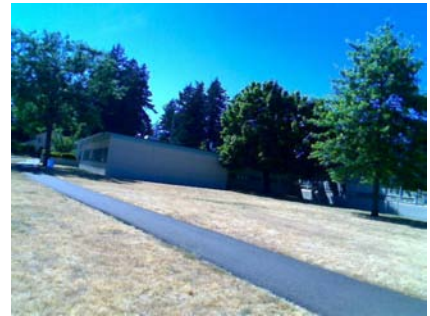
SE Plan Irregularity Primary

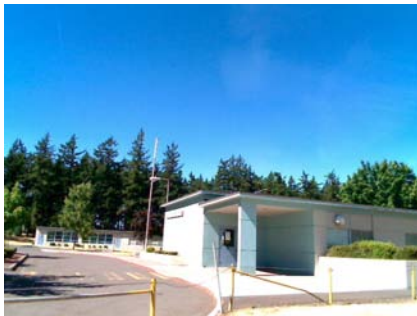
SW Plan Irregularity Primary
