Reynolds Learning Academy

Mult_sch161A

FEMA 154 Rapid Visual Screening Score Card

Rapid Visual Screening - Senate Bill #2 - Seismic Needs Assessment
Oregon Department of Geology and Mineral Industries

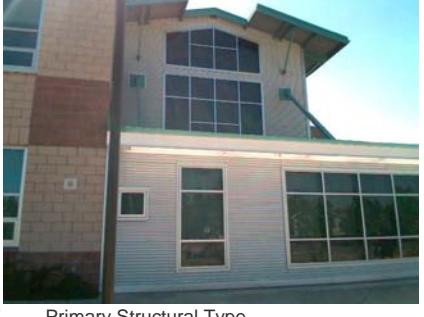
E Primary Structural Type CAN SEE S3 FRAMES IN TALL SPACE

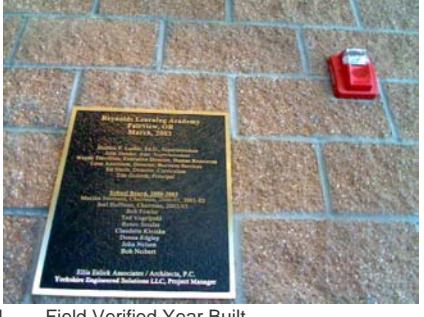
N Field Verified Year Built BLT 2003
