David Douglas High School

Mult_sch166A

FEMA 154 Rapid Visual Screening Score Card

Rapid Visual Screening - Senate Bill #2 - Seismic Needs Assessment
Oregon Department of Geology and Mineral Industries

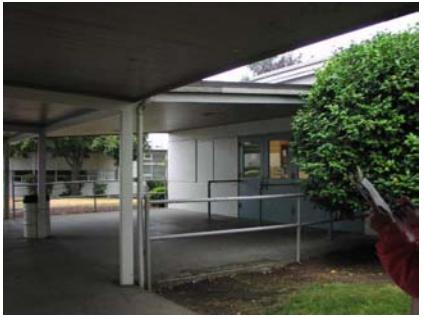
W Falling Hazard

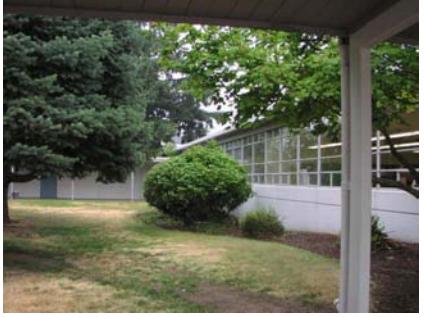
W Plan Irregularity Primary

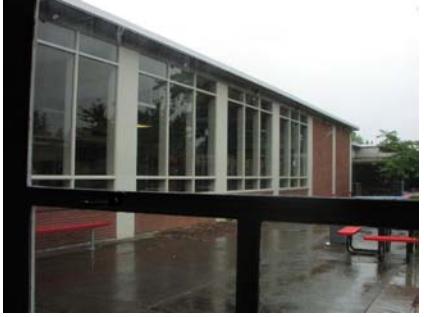
E Plan Irregularity Primary

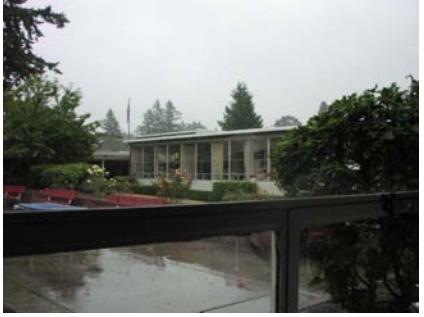
E Plan Irregularity Primary

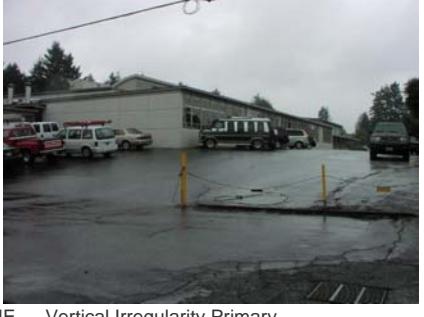
NE Vertical Irregularity Primary		E Falling Hazard

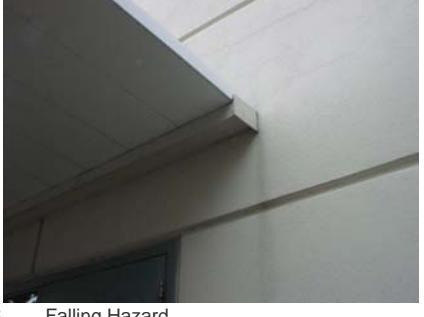
S Falling Hazard		SW Elevation View

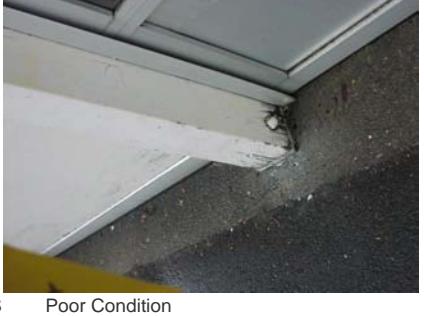
N Elevation View		S Poor Condition age of wood column
