Menlo Park Elementary School

Mult_sch17A

FEMA 154 Rapid Visual Screening Score Card

Rapid Visual Screening - Senate Bill #2 - Seismic Needs Assessment
Oregon Department of Geology and Mineral Industries

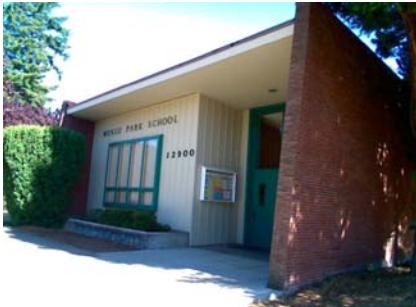
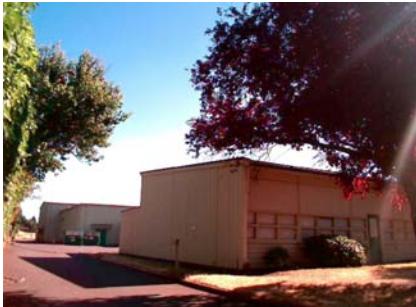
N Secondary Structural Type

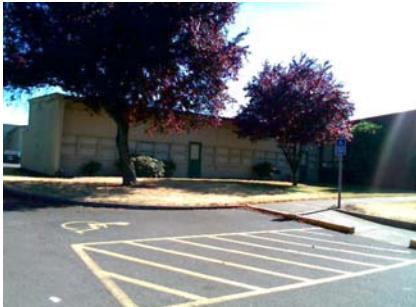
N Elevation View

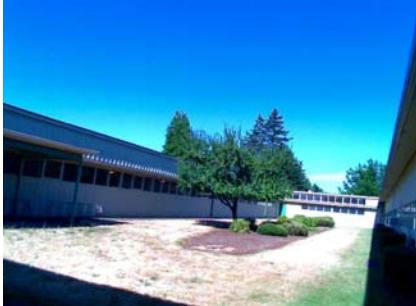
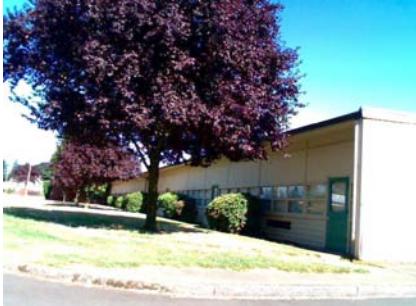
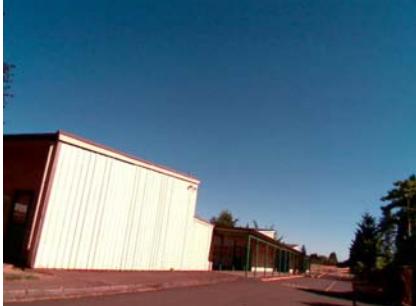
NW Elevation View		W Vertical Irregularity Primary

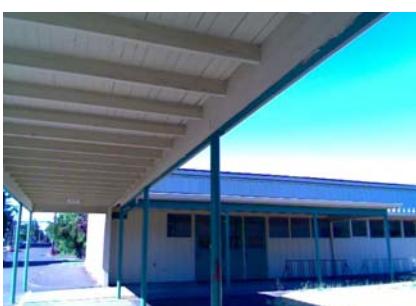
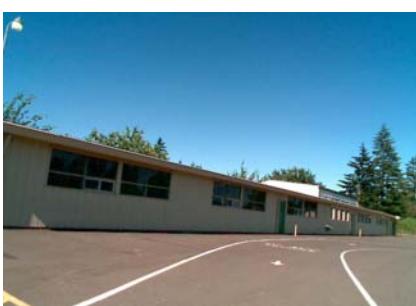
SW Falling Hazard

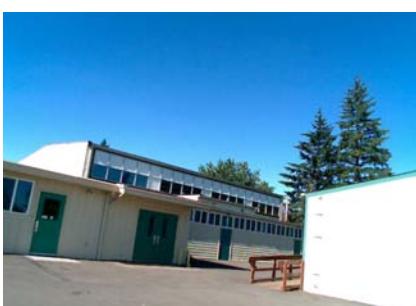
SW Primary Structural Type		S Vertical Irregularity Primary

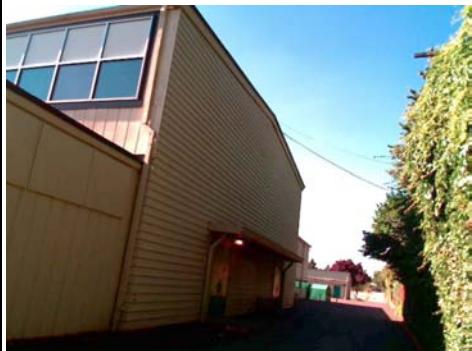
SE Elevation View

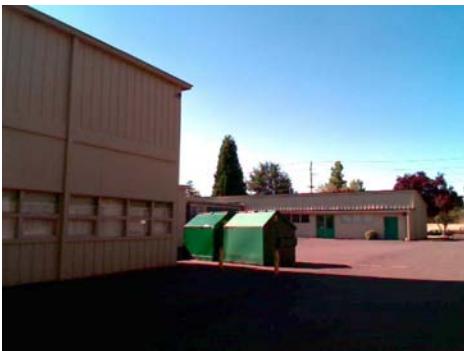
SE Elevation View
