Ventura Park Elementary School

David Douglas SD 40

Mult_sch19A

Rapid Visual Screening - Senate Bill #2 - Seismic Needs Assessment
Oregon Department of Geology and Mineral Industries

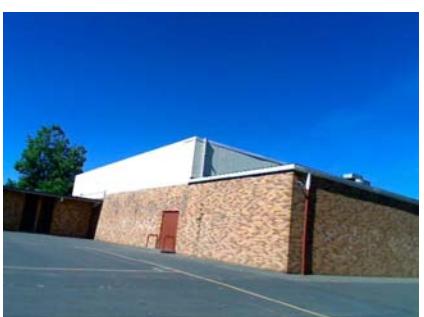
SW
Secondary Structural Type CONCRETE INTERIOR WALL TO LEFT IN MAINT AREA. CLAY TILE PARTITION WALL	Tertiary Structural Type

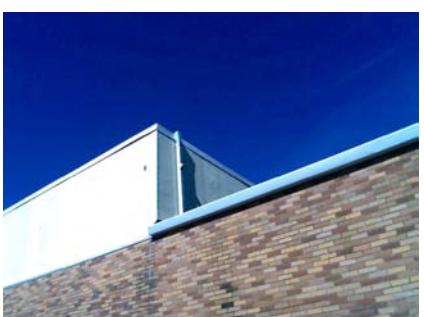
Tertiary Structural Type CAN SEE THE PLYWOOD HERE

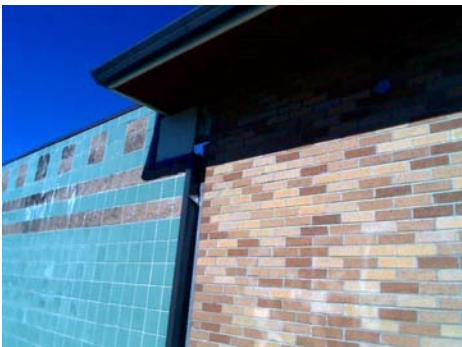
W Pounding Potential

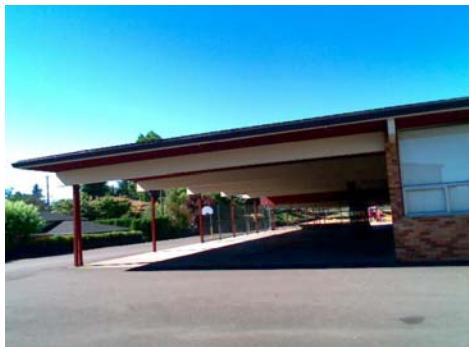
SW Falling Hazard

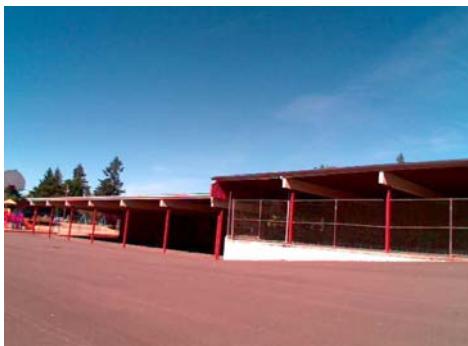
W Falling Hazard

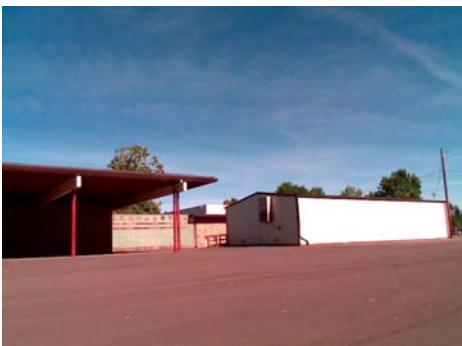
W Plan Irregularity Primary
