Floyd Light Middle School

Building Type	County
School	Multnomah
Street	
10800 Se Washington St	
City	State Zip
Portland	OR 97216
Latitude	Longitude
45.51755	122.55193
Tracking Code	Inspection Date
RVS in 2006	7/7/2006

FEMA 154 Rapid Visual Screening Score Card

Rapid Visual Screening - Senate Bill #2 - Seismic Needs Assessment
Oregon Department of Geology and Mineral Industries

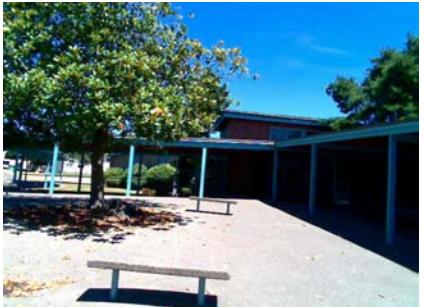
NW Number of Stories	N Elevation View	NE Elevation View

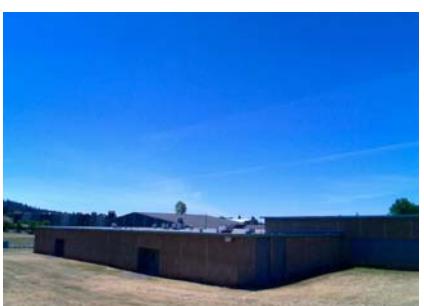
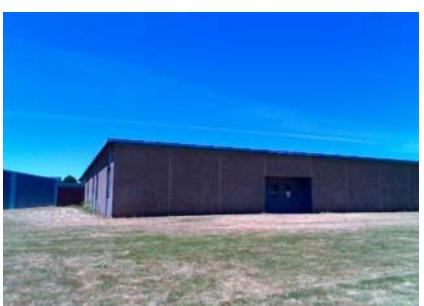
SE Elevation View	S Vertical Irregularity Secondary

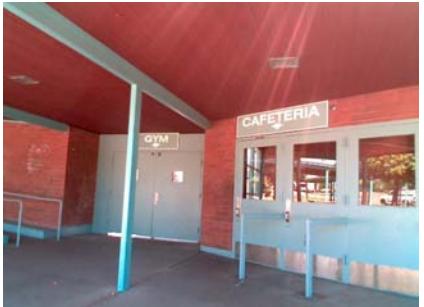
N Elevation View		N Pounding Potential

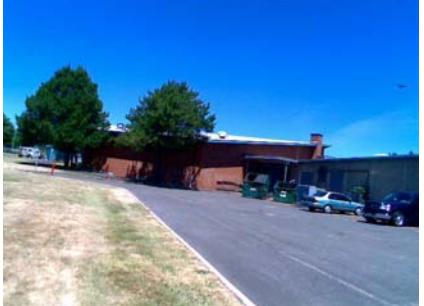
N Falling Hazard

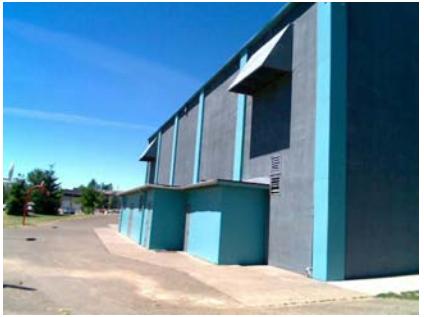
E	Primary Structural Type	S	Vertical Irregularity Primary

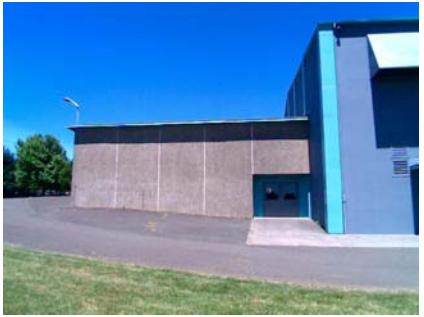
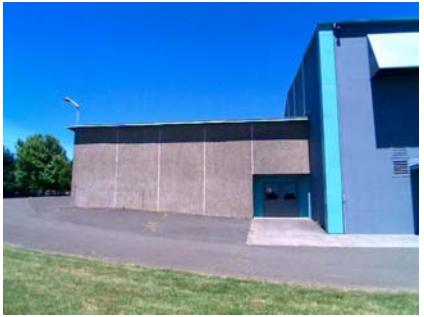
S	Vertical Irregularity Primary	S	Vertical Irregularity Primary
