# Riverdale Grade School

Mult\_sch25A

## FEMA 154 Rapid Visual Screening Score Card

Rapid Visual Screening - Senate Bill #2 - Seismic Needs Assessment  
Oregon Department of Geology and Mineral Industries

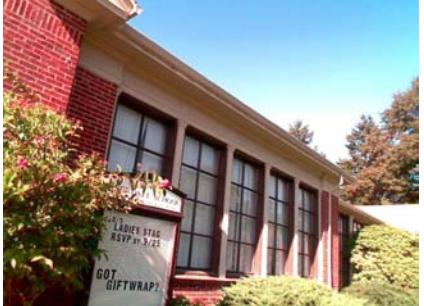
E Primary Structural Type WOOD DETAILS

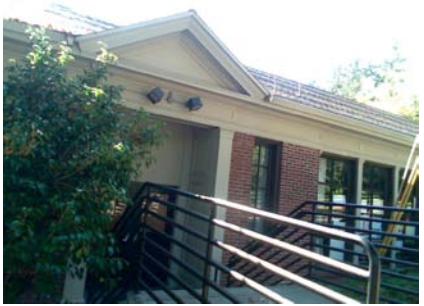
N Primary Structural Type WOOD DETAILS

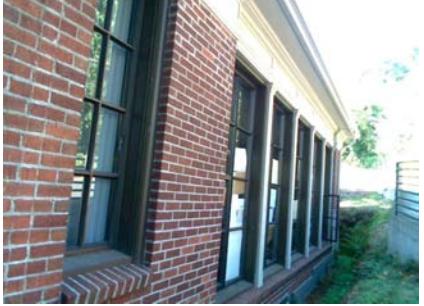
N Other VENEER DETAILS

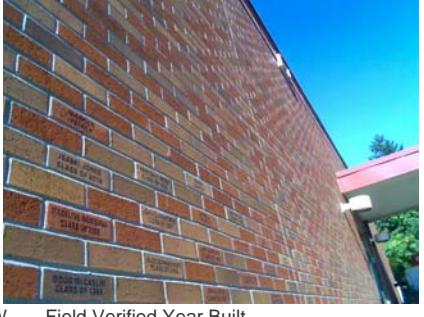
NW Elevation View		W Field Verified Year Built CLASS OF 2011 REPRESENTED ON BRICK DATES

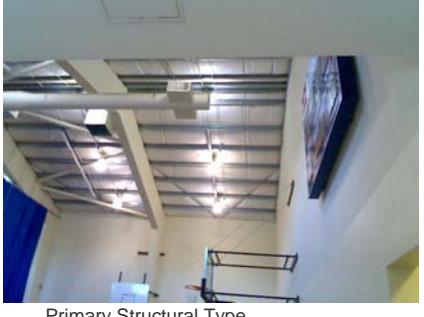
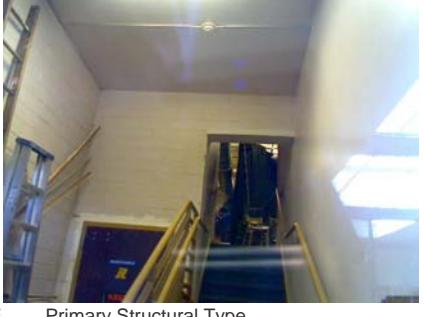
E Primary Structural Type I THINK OLD GYM ROOF WAS RELACED W S3 STRUCTURE, CUSTODIAN TELLS ME WALLS ARE ORIG		E Primary Structural Type OLD BLOCK WALLS AT STAIR - BLOCK SIZE ~6"X12"

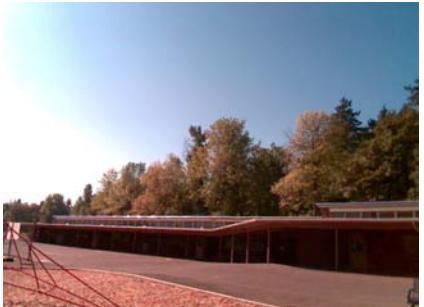
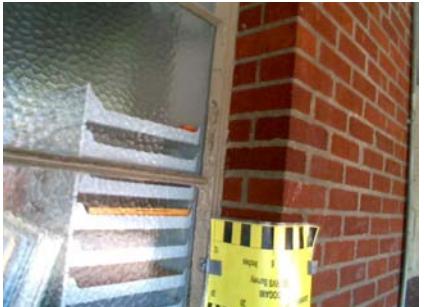
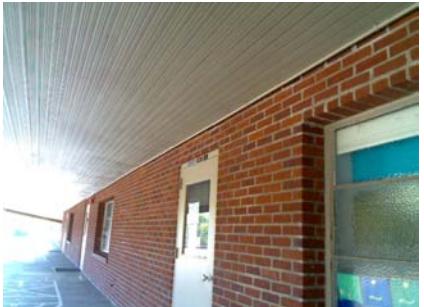
E Vertical Irregularity Primary
			E Primary Structural Type 6" THICK BRICKWORK OUTSIDE JAMB, TOTAL WALL THICKNESS > 12"

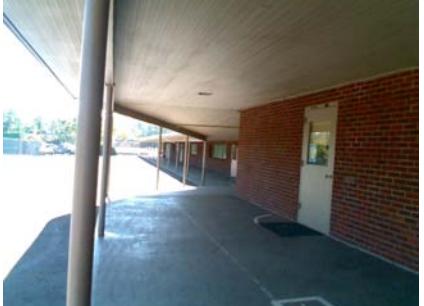
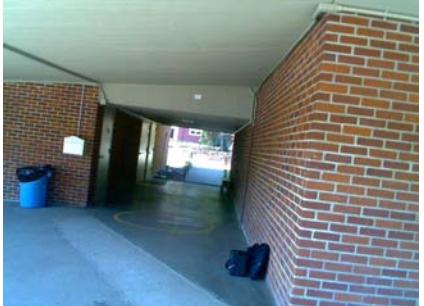
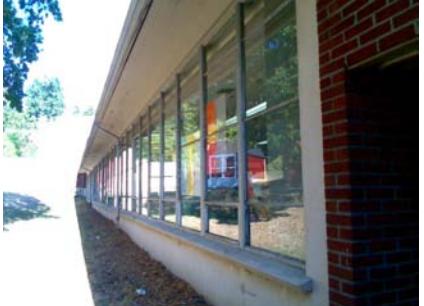
E Falling Hazard
			E Elevation View BREEZEWAY

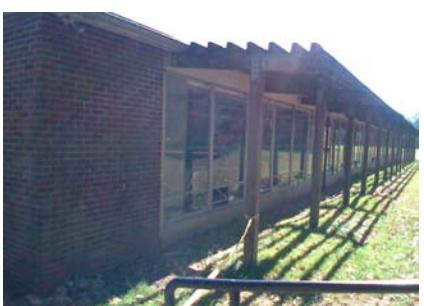
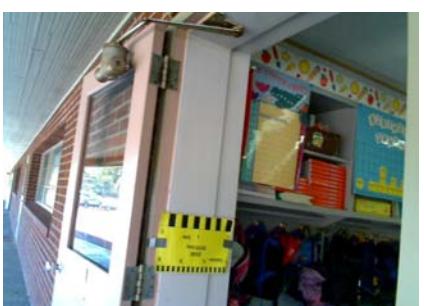
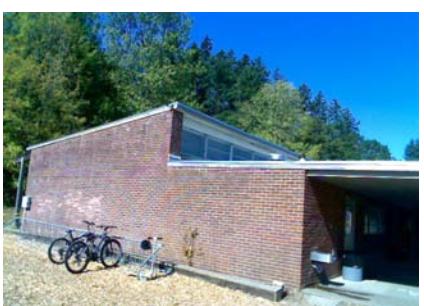
W Plan Irregularity Primary
			E Primary Structural Type THICK WALLS ON E SIDE

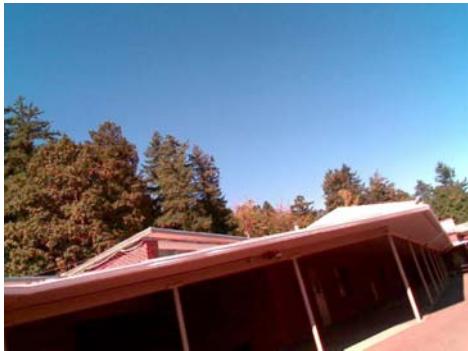
E Primary Structural Type  
~16-20" ENDWALL
