# Reynolds Middle School

Reynolds SD 7

Building Type School	County Multnomah	
Street 1200 NE 201st St		
City Fairview	State OR	Zip 97024
Latitude 45.53113	Longitude 122.45547	
Tracking Code RVS in 2006	Inspection Date 7/14/2006

Rapid Visual Screening - Senate Bill #2 - Seismic Needs Assessment  
Oregon Department of Geology and Mineral Industries

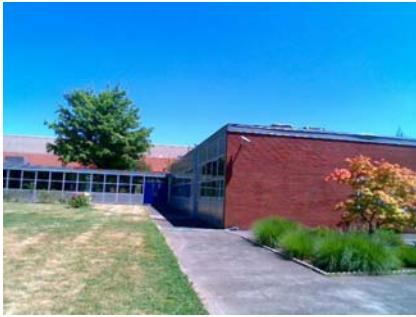
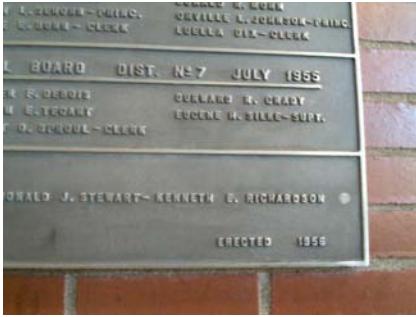
NW Plan Irregularity Secondary		W Field Verified Year Built

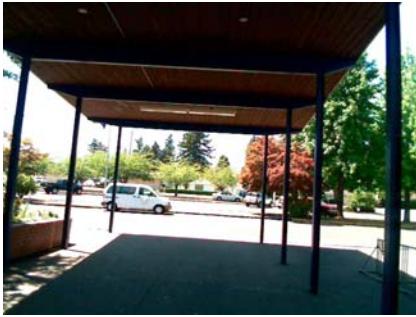
W Falling Hazard

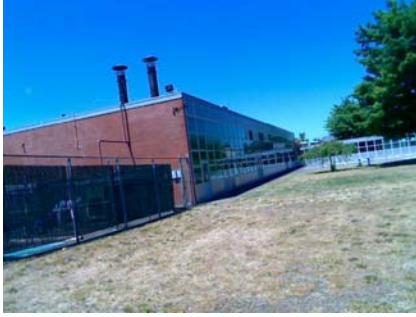
SE Plan Irregularity Secondary

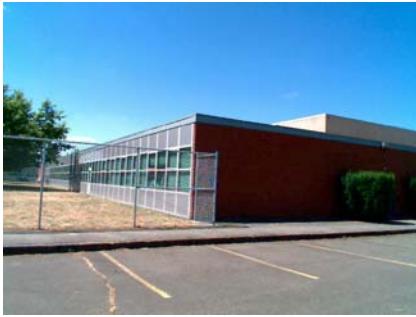
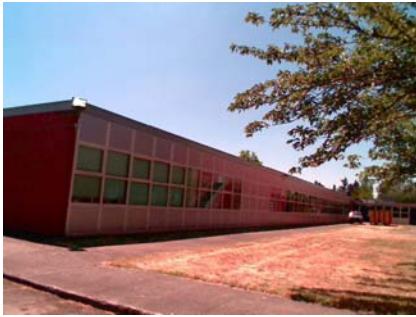
SE Elevation View		NE Plan Irregularity Secondary

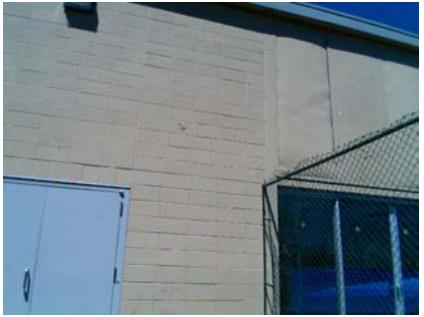
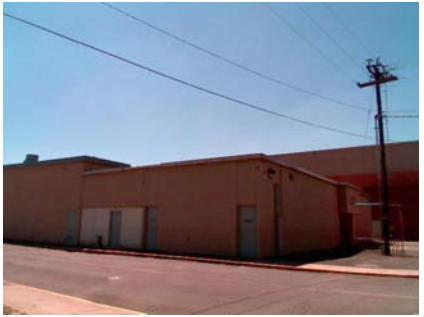
S	Primary Structural Type	NE	Elevation View

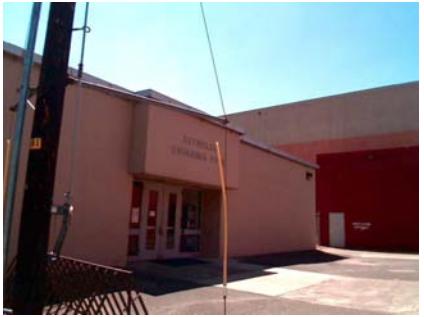
NE Falling Hazard

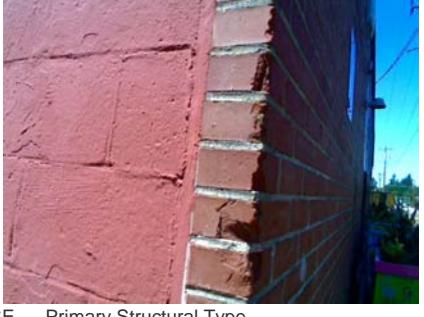
SE Primary Structural Type CAULKED JT

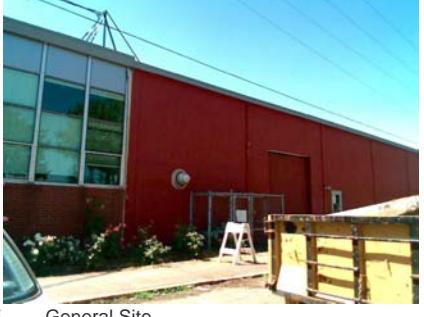
E General Site CONN TO F

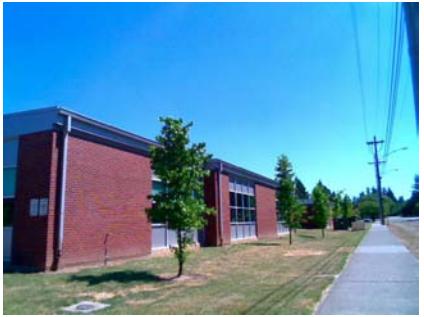
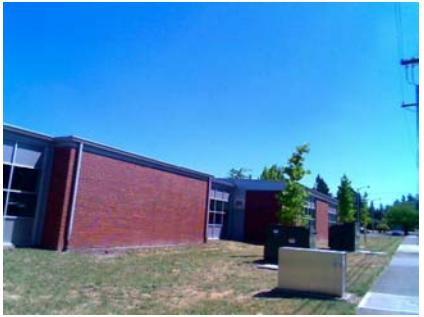
NW Plan Irregularity Primary		NW Plan Irregularity Primary

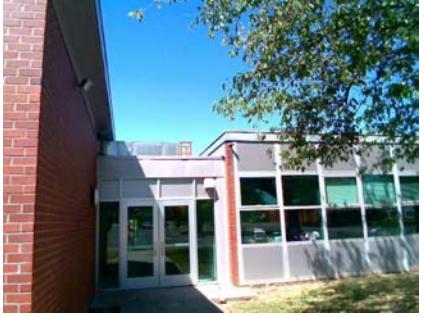
S Vertical Irregularity Primary S CONN TO H
