# Riverdale High School

Mult\_sch35A

## FEMA 154 Rapid Visual Screening Score Card

Rapid Visual Screening - Senate Bill #2 - Seismic Needs Assessment  
Oregon Department of Geology and Mineral Industries

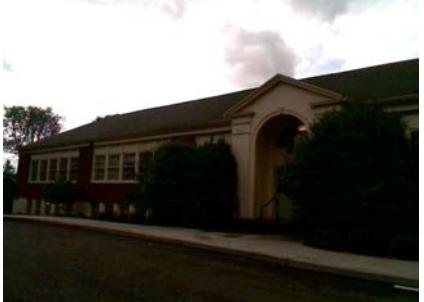
NE Vertical Irregularity Primary		E Elevation View
