FEMA 154 Rapid Visual Screening Score Card

Winterhaven School

Mult_sch49A

Rapid Visual Screening - Senate Bill #2 - Seismic Needs Assessment
Oregon Department of Geology and Mineral Industries

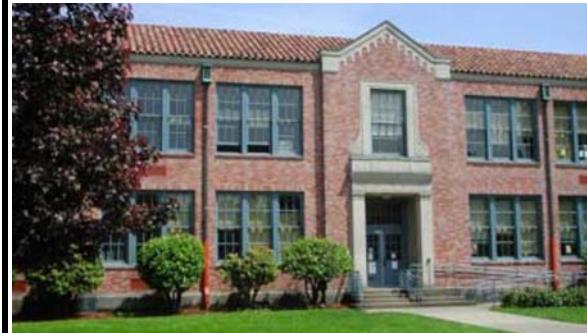
Type	Basic Score	Vert Irreg	Plan Irreg	Pre-Code	Post-Bench	Soil C	Soil D	Soil E	RVS Score
Primary	C2	2.8	-1	-0.5	-1	0	0	0	0	0.3
Secondary										
Tertiary										0

Final Type	Final Score
C2	0.3

Moderate (>1%)

Enrollment 339	Year Built (Field Verified) 1930	Year Built (Alt. Source) 1930	Est. Decade Built
Total Area (square ft) 38092	Number of Stories 2	Basement	Pounding Potential No
Plan Irregularities		Vertical Irregularities	
Falling Hazards		Poor Conditions
